Culvert Inspection Reports

CULVERT INSPECTION REPORT
EASTERN TRAIL EXTENSION PROJECT
From Milliken Mills Road in Old Orchard Beach to
Thornton Academy in Saco

Inspection Date: 9/28/09

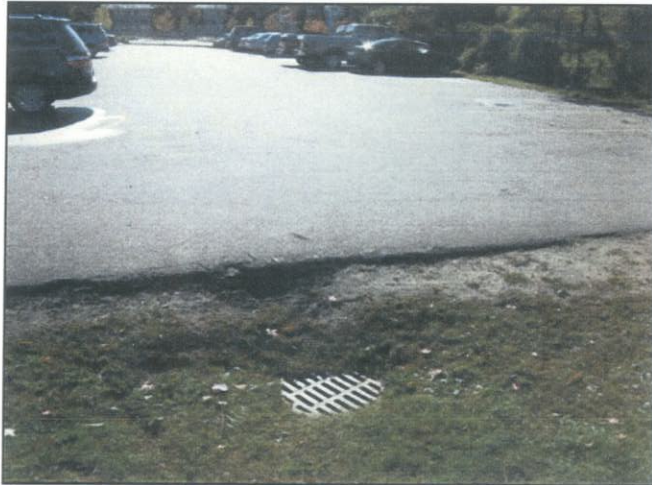
INSPECTION #1	Inlet	Outlet
Approximate Location:	Thornton Academy Campus parking area for middle school southeast of baseball field	Thornton Academy Campus parking area for middle school southeast of baseball field
Any nearby existing features:	Thornton Academy	Thornton Academy
Size:	CB with 8-inch outlet	8" PVC
Material:	PVC Culvert	PVC Culvert
Condition of Culvert:	Good	Good
Does pipe appear to be undersized:	No	No
Flow Direction:	North to south under parking area	North to south under parking area
Sedimentation:	No	Unknown
Erosion:	Yes	Unknown
General Comments:	- CB not inspected as part of this review - Minor erosion along EOP to be repaired	- Outlet cannot be found - May be buried by piled debris

Catch basin inlet looking southeast

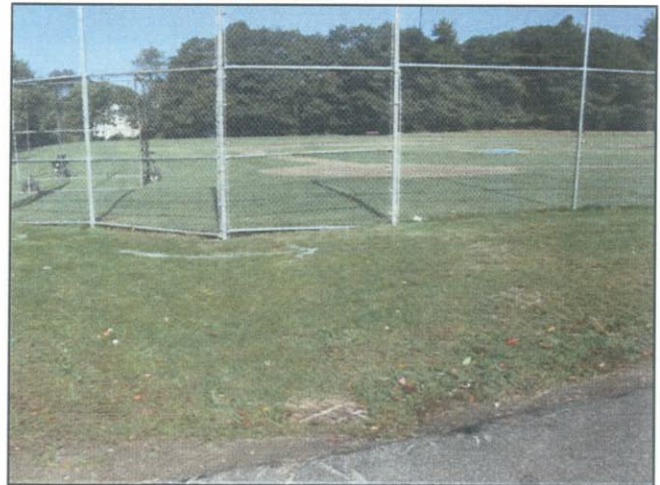
Catch basin inlet looking northwest

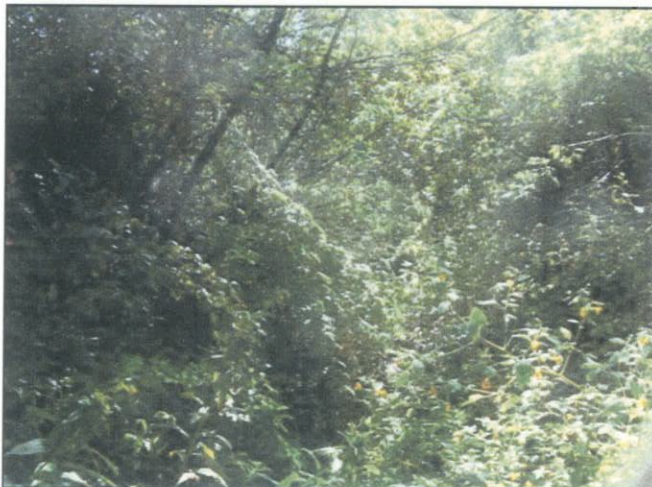
Potential outlet ditch looking southeast
