**Culvert Inspection Reports**

DeLUCA-HOFFMAN ASSOCIATES, INC.  
CONSULTING ENGINEERS

**CULVERT INSPECTION REPORT**  
EASTERN TRAIL EXTENSION PROJECT  
From Milliken Mills Road in Old Orchard Beach to  
Thornton Academy in Saco

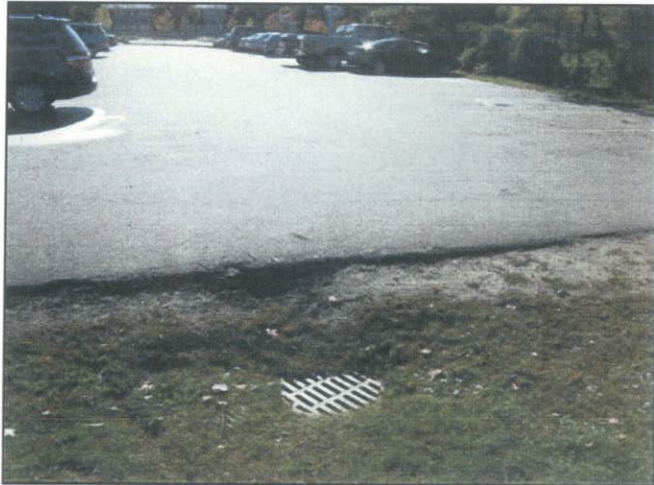
| INSPECTION #1 | Inlet | Outlet |
|---|---|--|
| <b>General Comments:</b> | - CB not inspected as part of this review<br>- Minor erosion along EOP to be repaired | - Outlet cannot be found<br>- May be buried by piled debris |

Catch basin inlet looking southeast

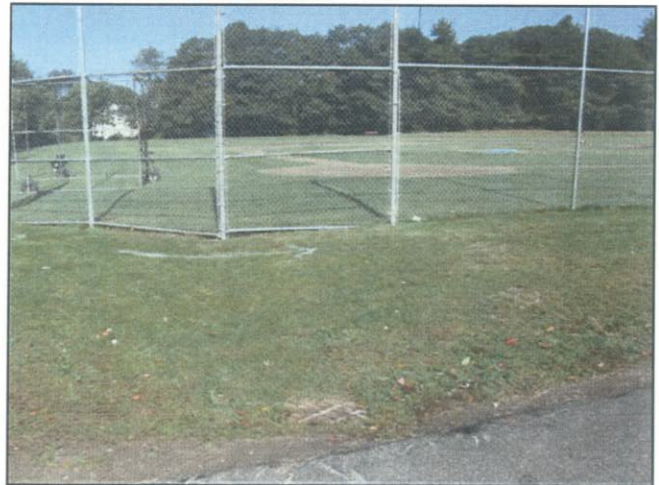
Catch basin inlet looking northwest

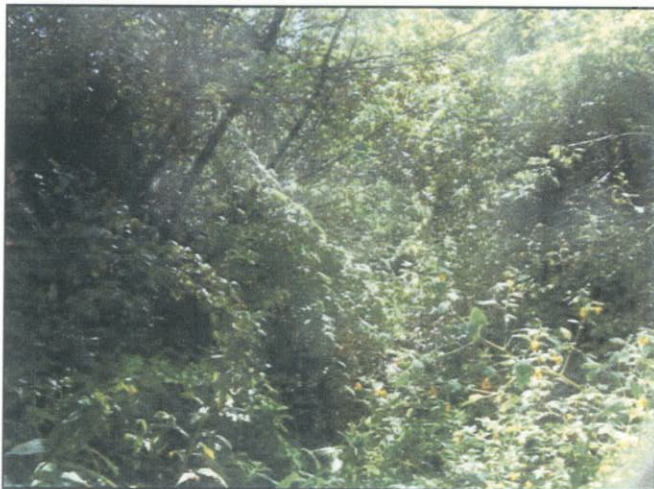
Potential outlet ditch looking southeast

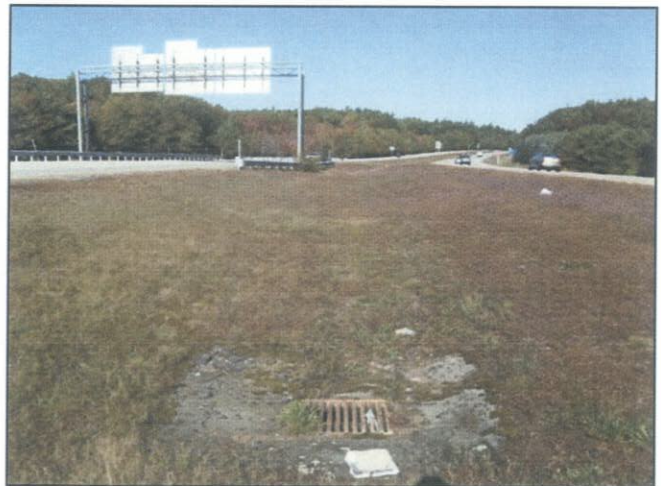
Catch basin inlet looking northwest

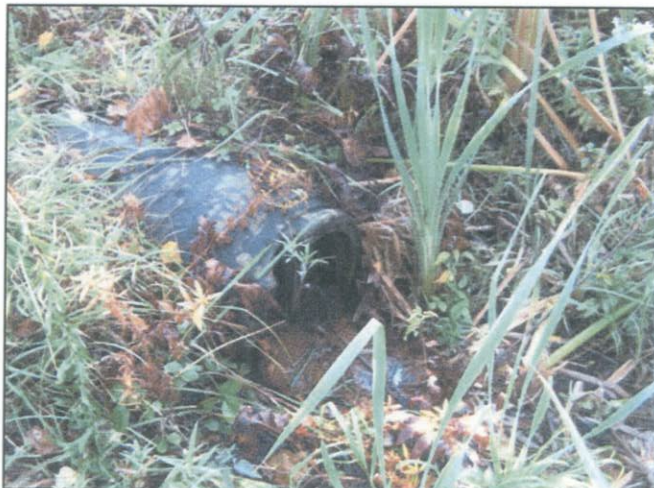
| INSPECTION #2 | Inlet | Outlet |
|---|---|---|
| <b>General Comments:</b> | <ul style="list-style-type: none"> <li>- CB not inspected as part of this review</li> <li>- CB has 6'x6' paved apron within ditch bottom</li> </ul> | <ul style="list-style-type: none"> <li>- RCP pipe chipped at top of pipe</li> <li>- Proposed Trail will cross over the outlet</li> <li>- Culvert extension may be required</li> </ul> |

Outlet looking northeast

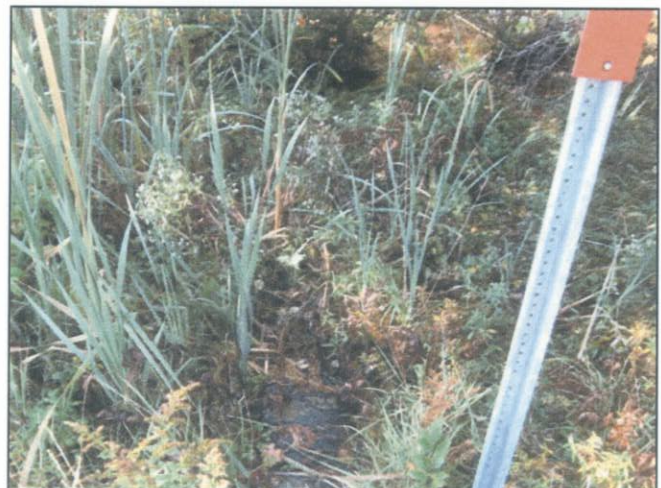
Outlet outfall looking southwest

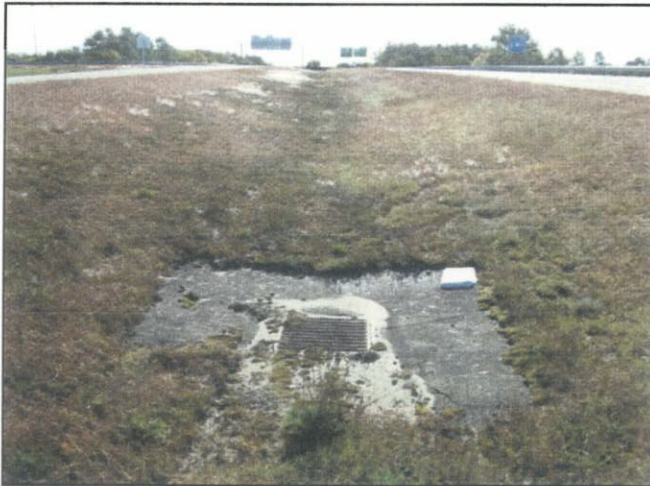
| INSPECTION #3 | Inlet | Outlet |
|---|---|--|
| <b>General Comments:</b> | <ul style="list-style-type: none"> <li>- CB not inspected as part of this review</li> <li>- CB has 6'x6' paved apron within ditch bottom</li> </ul> | <ul style="list-style-type: none"> <li>- Dense vegetation</li> <li>- Outlet marked with a sign</li> <li>- Proposed Trail will cross over near the outlet, recommend culvert extension</li> </ul> |

Catch basin inlet looking southeast

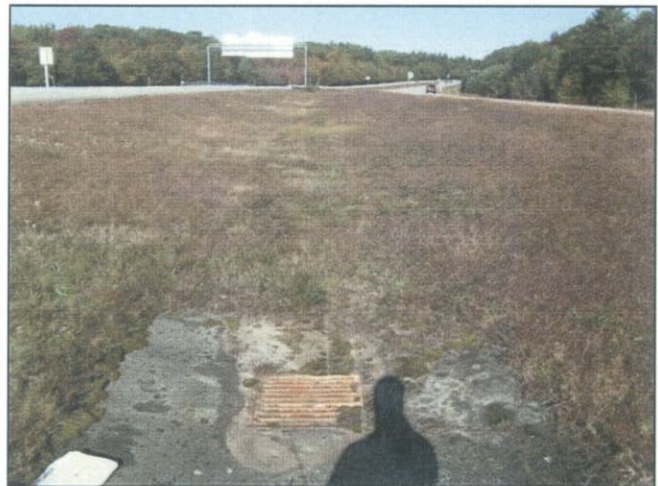
Catch basin inlet looking northwest

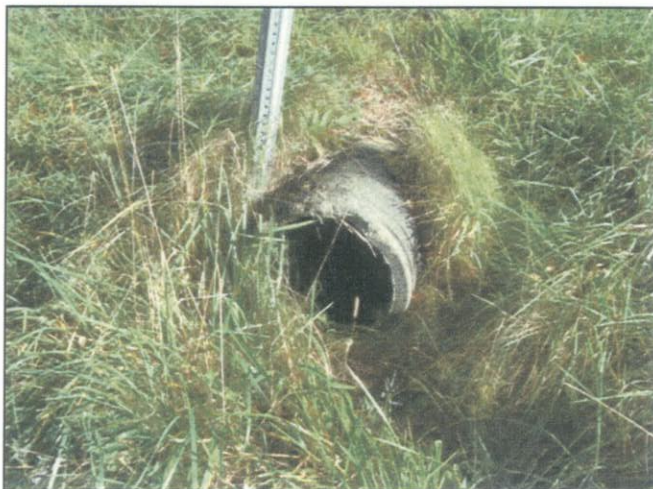
Outlet looking northeast

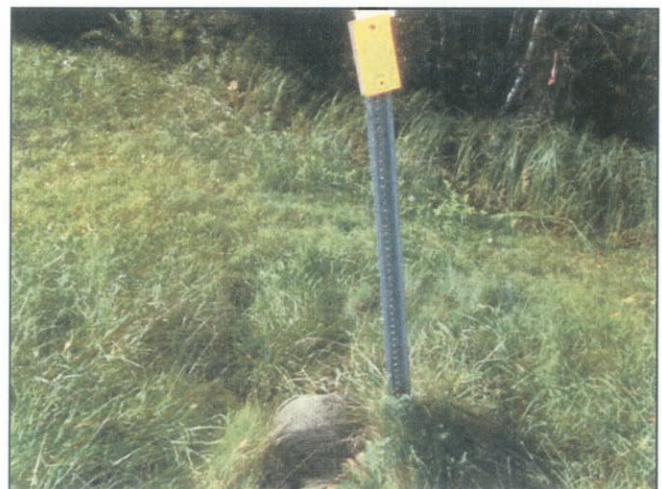
Outlet outfall looking southwest

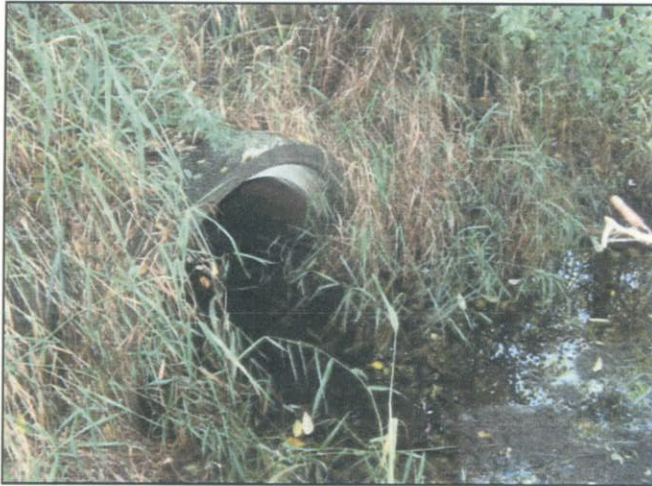
| INSPECTION #4 | Inlet | Outlet |
|---|---|--|
| <b>General Comments:</b> | <ul style="list-style-type: none"> <li>- Low storage area upstream</li> <li>- Dense vegetation</li> <li>- Proposed Trail will cross over the existing inlet, recommend culvert extension</li> </ul> | <ul style="list-style-type: none"> <li>- Dense vegetation</li> <li>- Flows through ditch to pond along U.S. Route 1</li> </ul> |

Inlet looking northeast

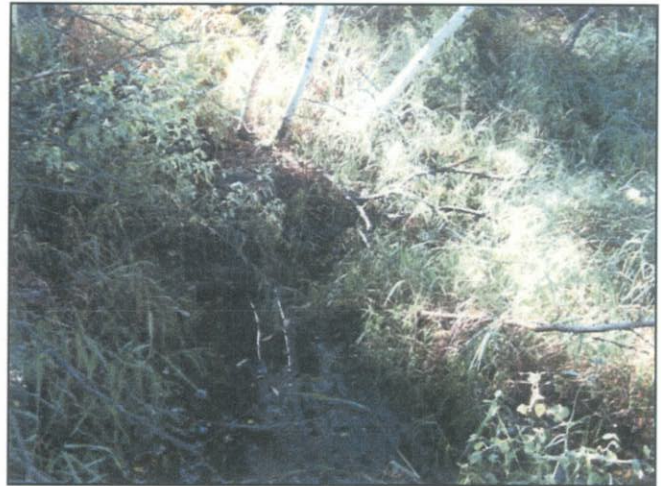
Inlet ditch looking southeast

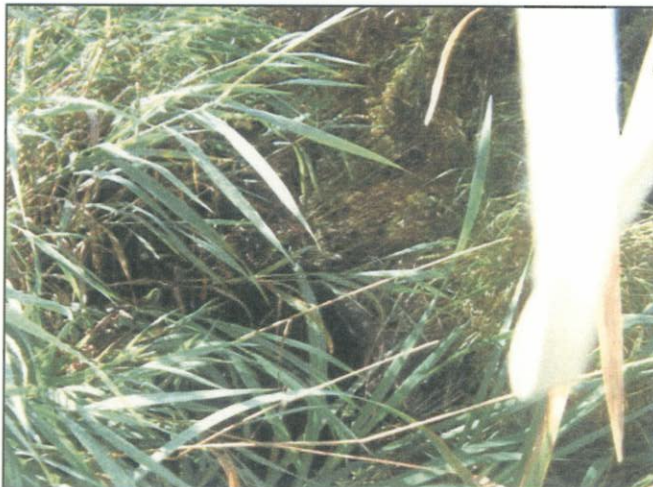
Outlet looking southeast

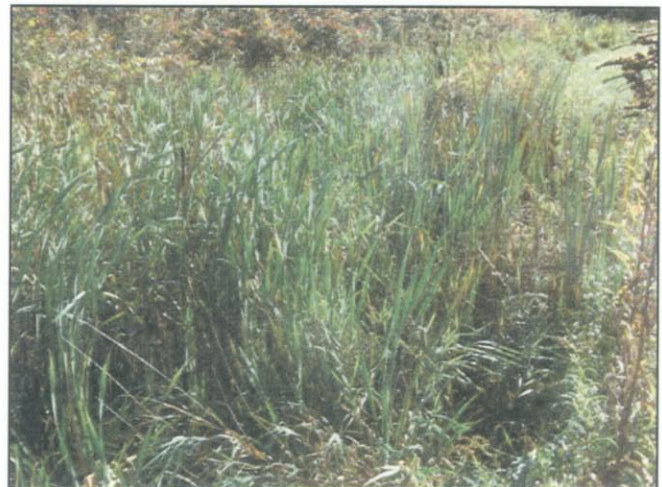
Outlet outfall looking northeast

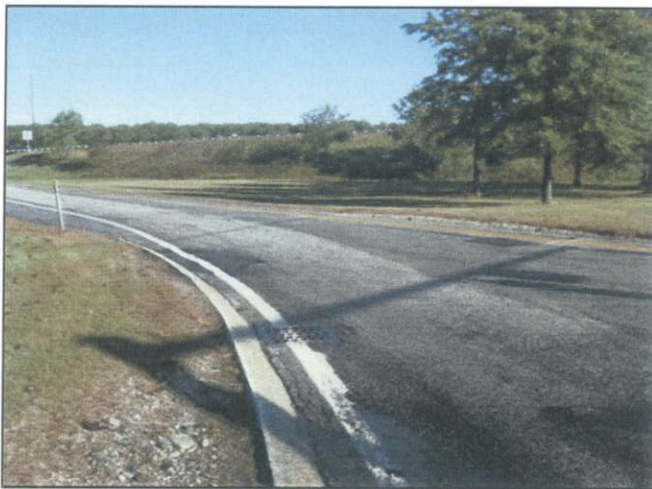
Inlet catch basin looking north

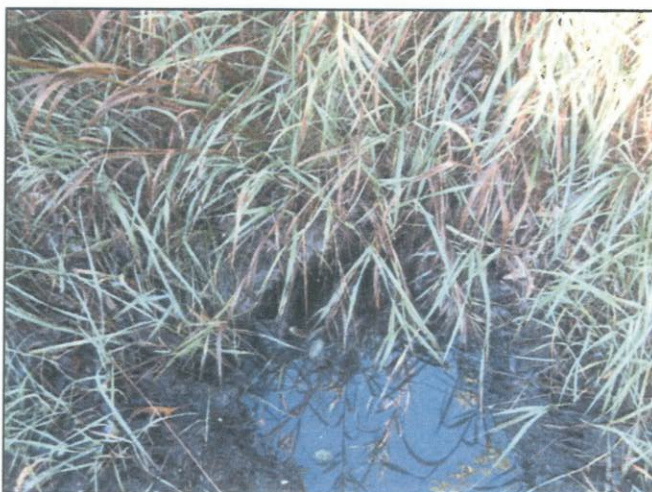
| INSPECTION #5 | Inlet | Outlet |
|---|---|---|
| <b>General Comments:</b> | - CB not inspected as part this review | - Pipe buried, recommend removal of sediment<br>- Recommend vegetation be trimmed at outlet<br>- This culvert is beneath the EB off-ramp from I-195. No Trail activities are currently contemplated in this culvert |

Outlet looking southwest

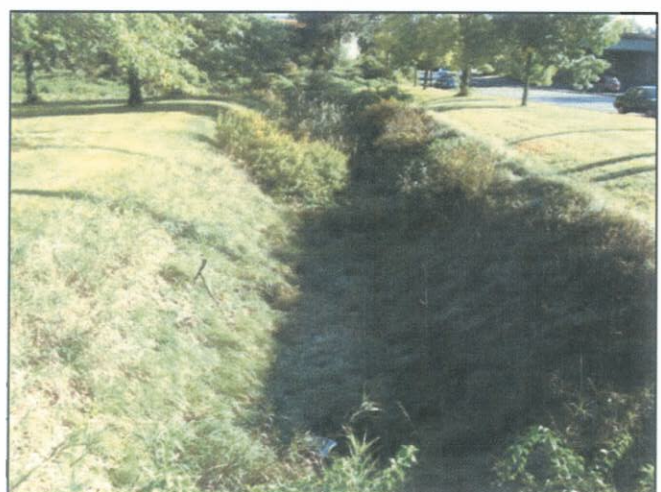
Outlet outfall to pond looking northeast

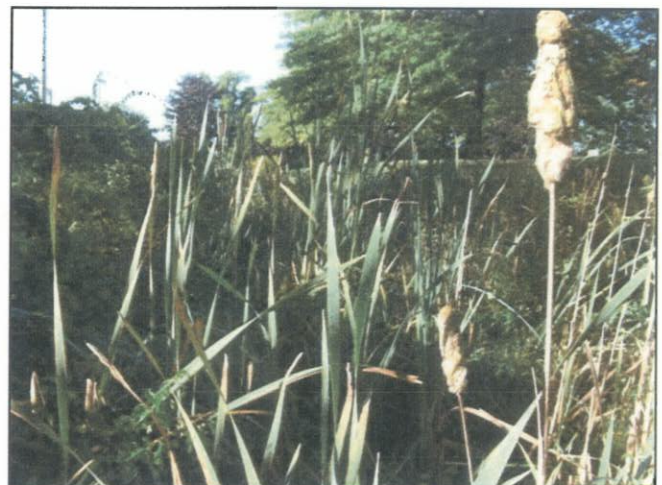
| INSPECTION #6 | Inlet | Outlet |
|---|---|--|
| <b>General Comments:</b> | - Dense vegetation<br>- Few small stones | - Dense vegetation<br>- Culvert partially buried |

Inlet pond looking southwest

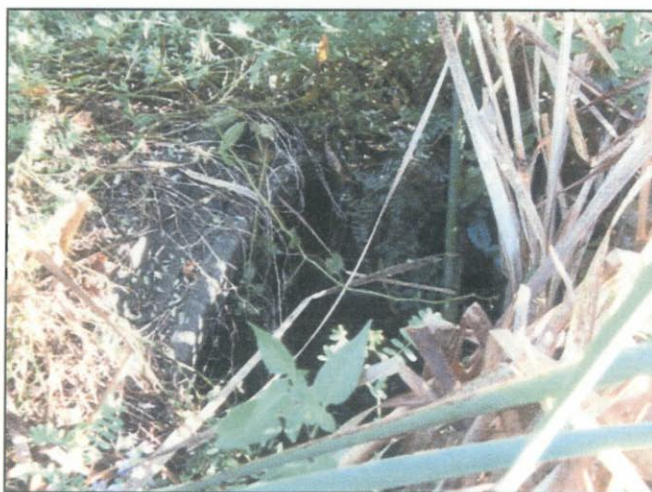
| INSPECTION #6 | Inlet | Outlet |
|---|---|--|
| <b>Sedimentation:</b> | No | 12-inches (pipe partially buried) |

Outlet looking northwest

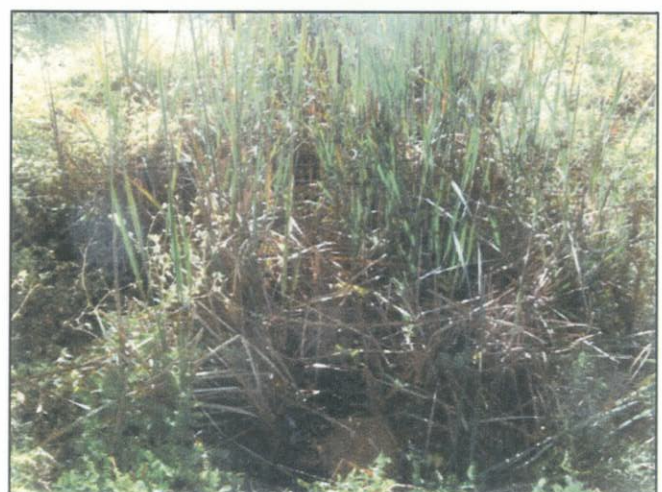
Outlet outfall looking southeast

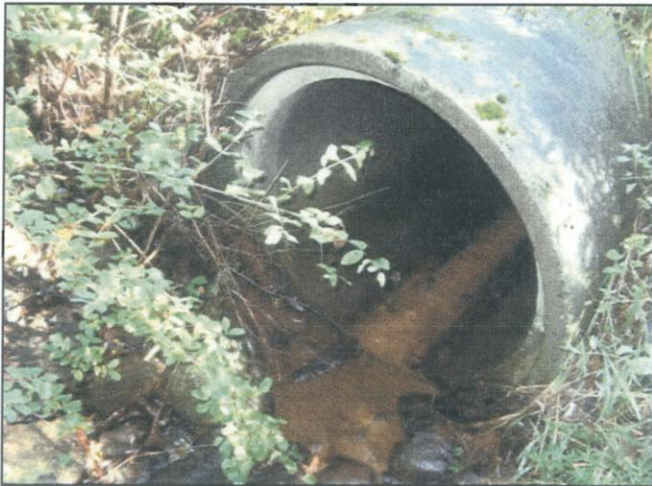
| INSPECTION #7 | Inlet | Outlet |
|---|--|--|
| <b>Erosion:</b> | Minor | No |
| <b>General Comments:</b> | <ul style="list-style-type: none"> <li>- Few small stones in stream bed</li> <li>- Dense vegetation</li> <li>- This culvert conveys an unnamed tributary to Goosefare Brook</li> <li>- No Trail activities are contemplated in the area of this culvert</li> </ul> | <ul style="list-style-type: none"> <li>- Dense vegetation at outlet</li> <li>- No trail activities are contemplated in the area of this culvert</li> </ul> |

Inlet looking east

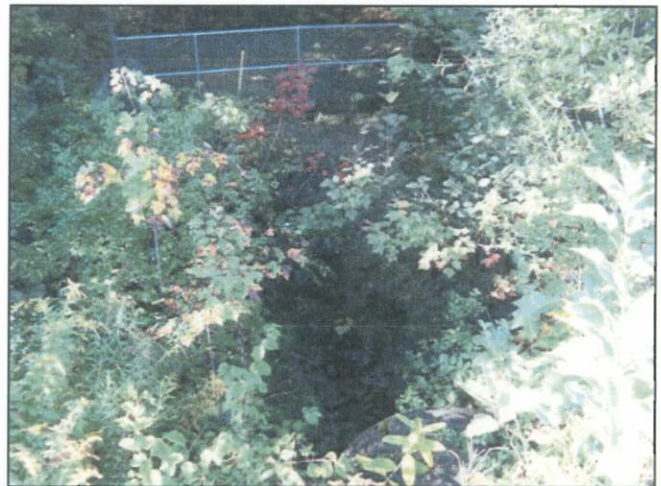
Inlet ditch looking west

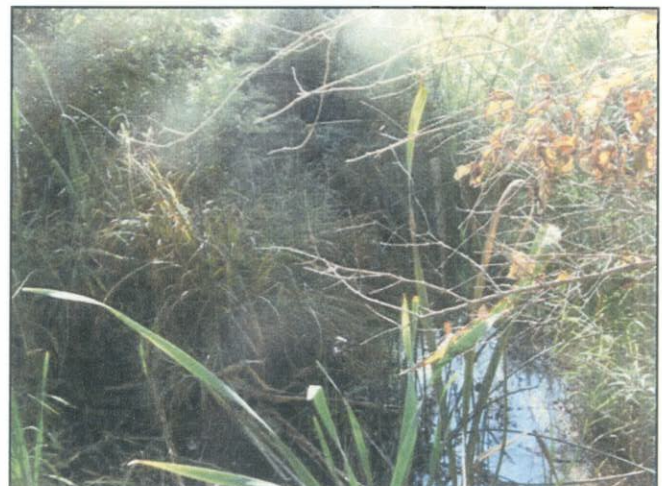
Outlet outfall looking west

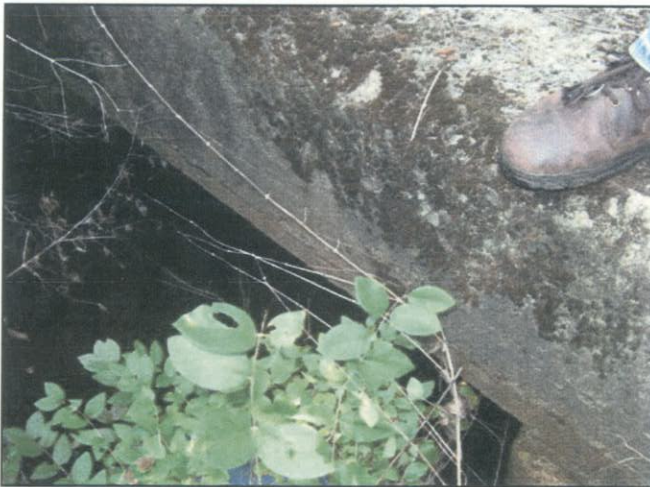
| INSPECTION #8 | Inlet | Outlet |
|---|--|--|
| <b>General Comments:</b> | - Dense vegetation to be trimmed | - Dense vegetation/tree growth to be trimmed<br>- Soil stabilization needed – Recommend riprap be considered |

Inlet looking southeast

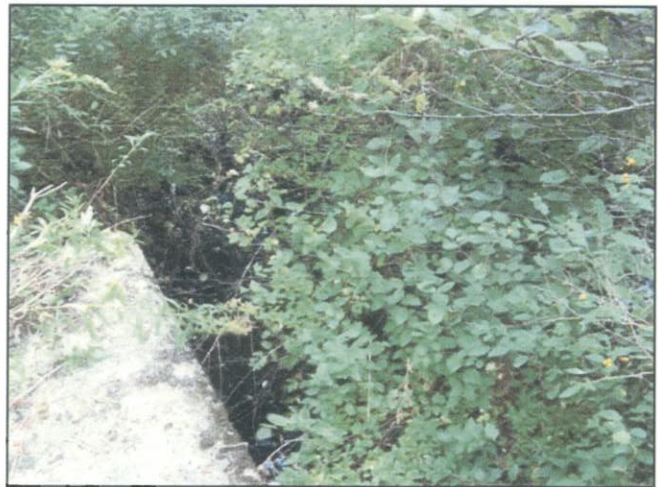
Inlet ditch looking west

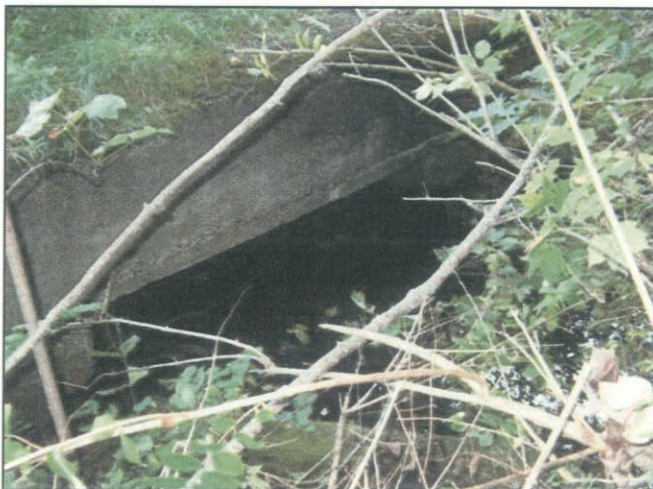
| INSPECTION #8 | Inlet | Outlet |
|---|--|--|
| <b>Erosion:</b> | No | Yes - minor |

Outlet looking northwest

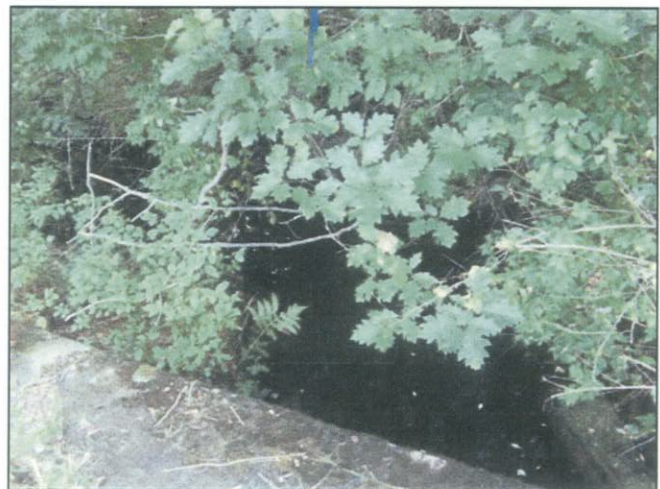
Outlet outfall looking southeast

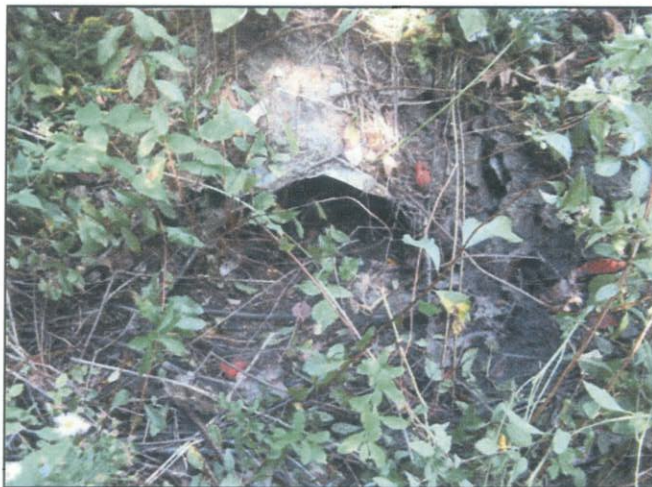
| INSPECTION #9 | Inlet | Outlet |
|---|---|--|
| <b>Sedimentation:</b> | 10-inches | 8-inches |
| <b>General Comments:</b> | <ul style="list-style-type: none"> <li>- Dense vegetation in ditch</li> <li>- Limited cover over pipe</li> <li>- No flow</li> </ul> | <ul style="list-style-type: none"> <li>- Recommend sediment to be removed from pipe and inlet/outlet areas stabilized with riprap – Pipe to be replaced to allow for ditch modifications.</li> </ul> |

Inlet looking northeast

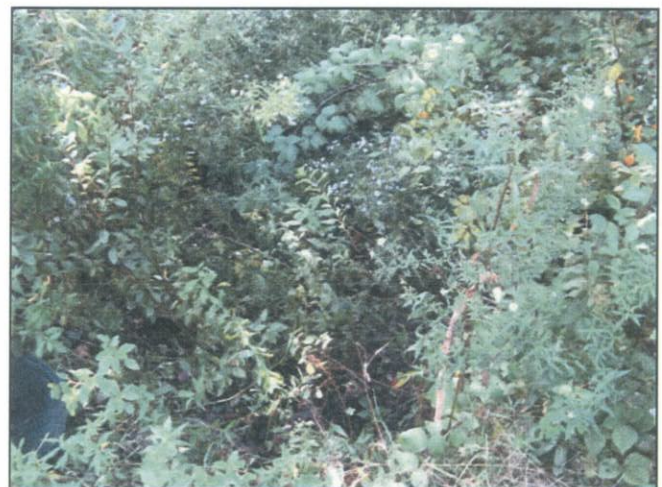
Inlet ditch looking southwest

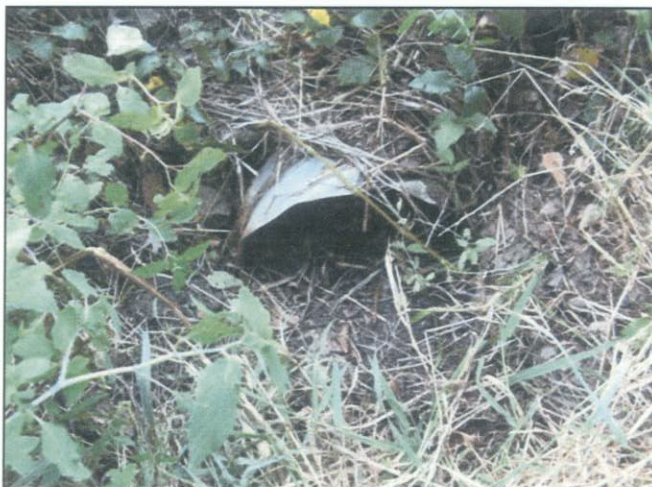
Outlet looking southwest

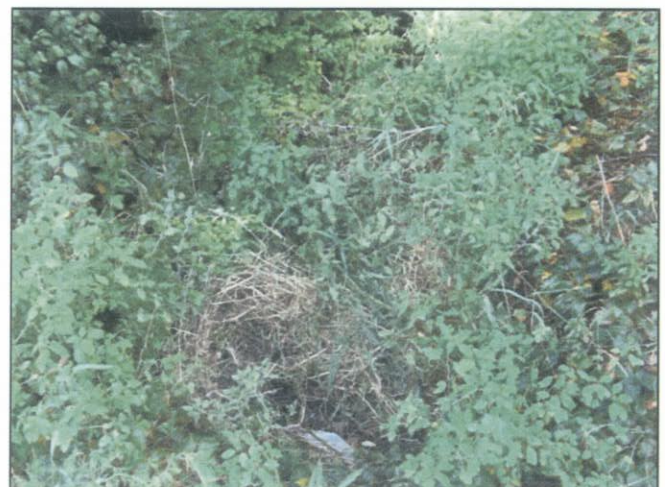
Outlet ditch looking northeast

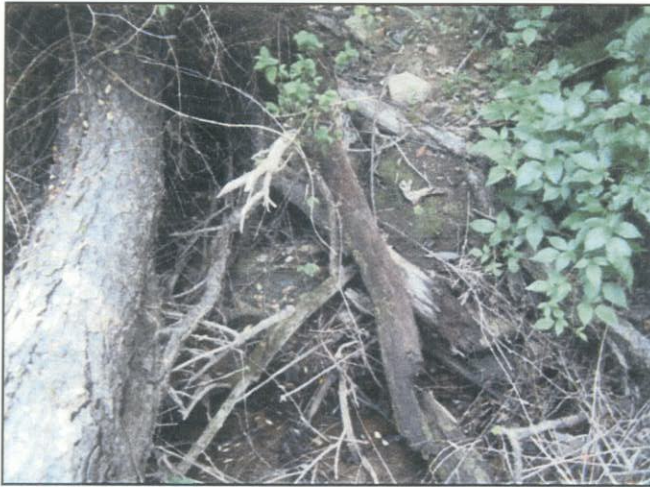
| INSPECTION #10 | Inlet | Outlet |
|---|---|---|
| <b>Erosion:</b> | Major | Yes |
| <b>General Comments:</b> | <ul style="list-style-type: none"> <li>- Slope has eroded over inlet</li> <li>- Unable to confirm existing conditions</li> <li>- Recommend inlet repairs and stabilization to improve conditions</li> </ul> | <ul style="list-style-type: none"> <li>- Large stones and debris blocking outflow downstream of outlet</li> </ul> |

Potential inlet looking east

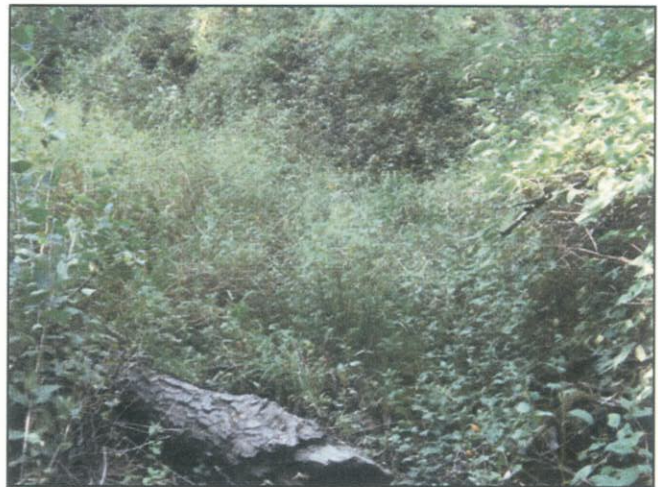
Potential inlet ditch looking northwest

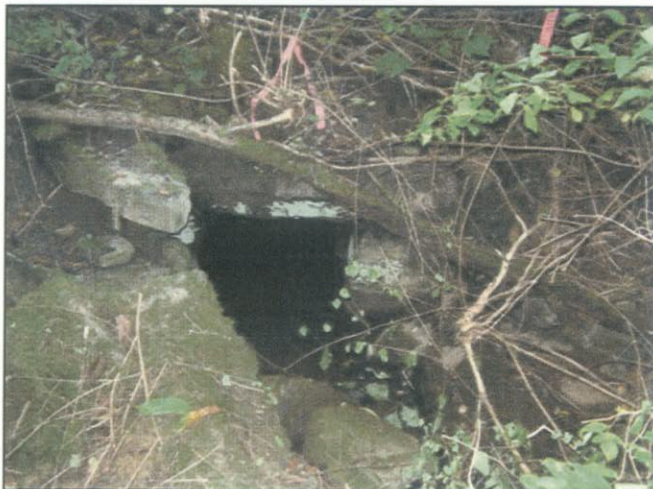
| INSPECTION #10 | Inlet | Outlet |
|---|---|---|
| <b>Sedimentation:</b> | Unknown | 6-inches |

Outlet looking northwest

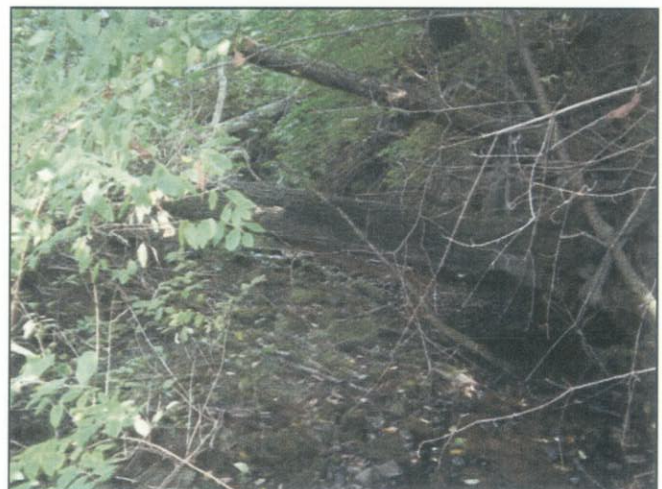
Outlet outfall looking southeast

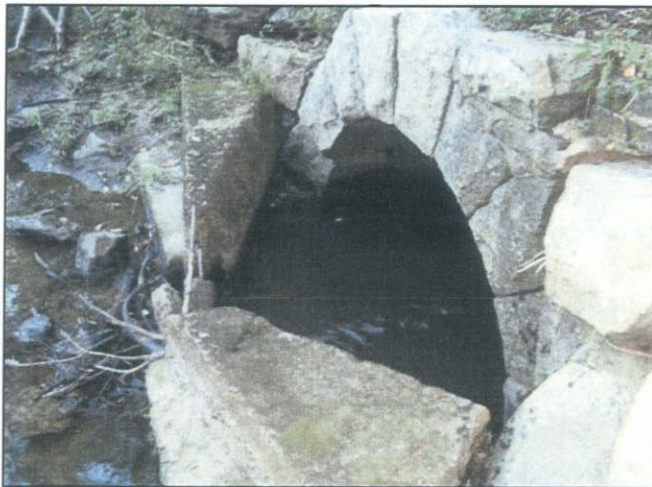
| INSPECTION #11 | Inlet | Outlet |
|---|---|--|
| <b>General Comments:</b> | <ul style="list-style-type: none"> <li>- Concrete weir broken, needs to be repaired</li> <li>- Significant tree debris has formed dam creating large pond of water upstream of inlet</li> <li>- possible beaver activity</li> </ul> | <ul style="list-style-type: none"> <li>- Water ponded to almost top of structure</li> <li>- Downstream conditions should be inspected</li> </ul> |

Inlet looking east

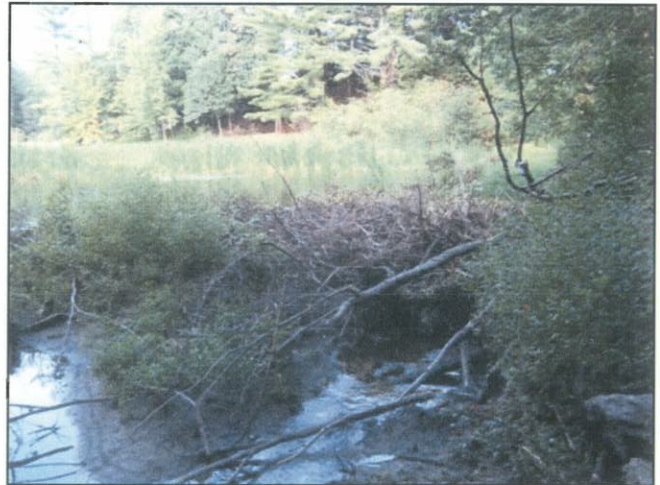
Inlet upstream ponded area looking north

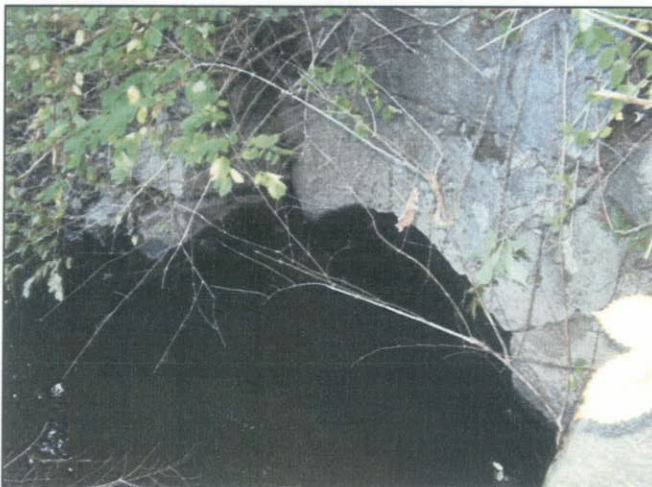
Outlet looking west

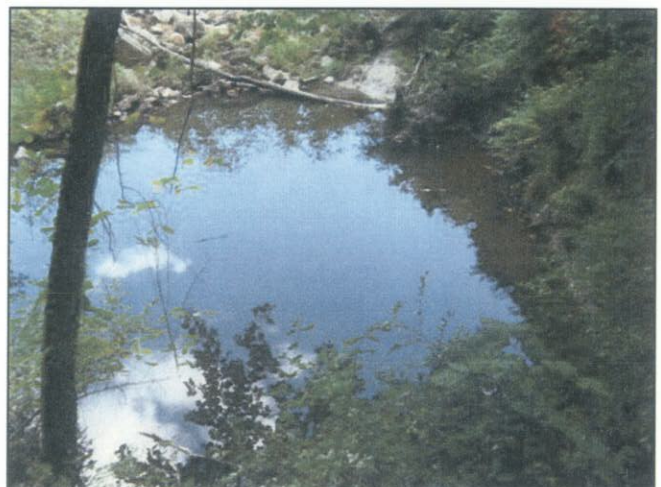
Outlet outfall looking southeast

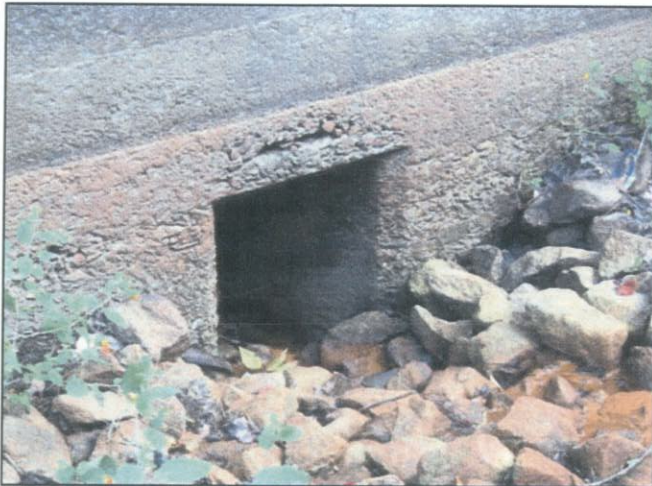
Inlet looking south

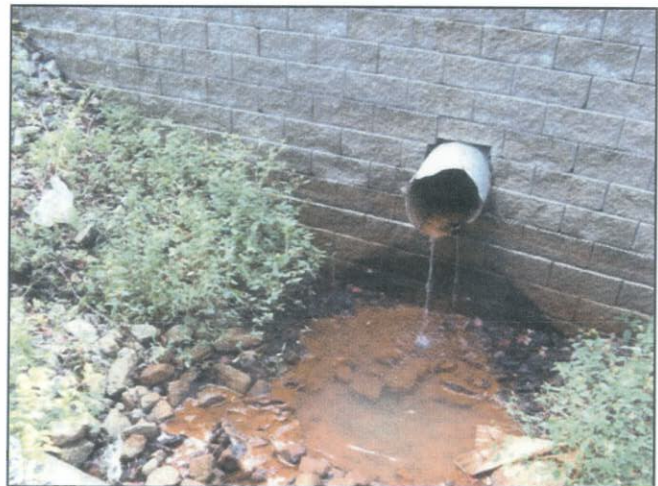
| INSPECTION #12 | Inlet | Outlet |
|---|--|---|
| <b>General Comments:</b> | <ul style="list-style-type: none"> <li>- Outfall from Seacoast RV appears to be corroded pipe (rust colored flow)</li> </ul> | <ul style="list-style-type: none"> <li>- Ditch slopes have been stabilized with fabric</li> <li>- Significant erosion has occurred at this location</li> <li>- Recommend additional stabilization of outfall ditch</li> </ul> |

Seacoast RV site outfall looking northwest

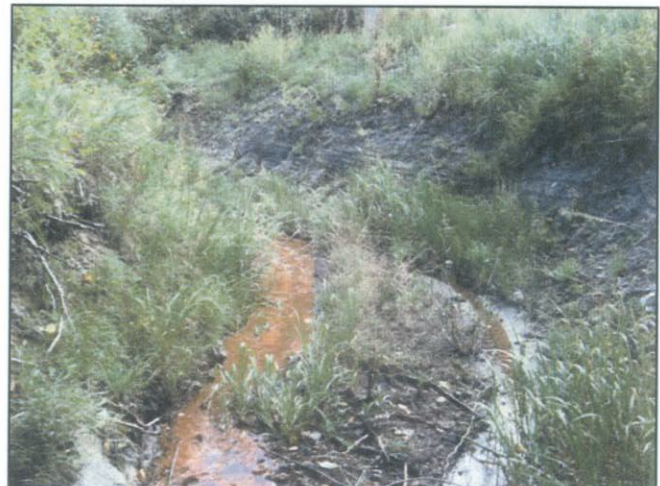
| INSPECTION #12 | Inlet | Outlet |
|---|--|---|
| <b>Erosion:</b> | None | Yes |

Outlet outfall looking southeast

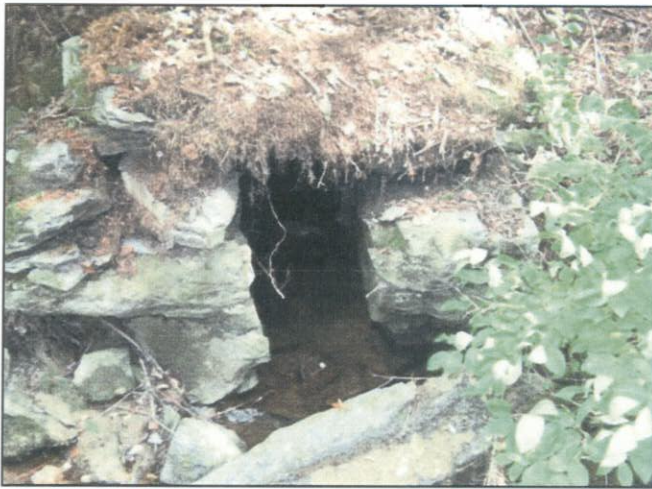
| INSPECTION #13 | Inlet | Outlet |
|---|---|--|
| <b>General Comments:</b> | <ul style="list-style-type: none"> <li>- Some stones have fallen off the box culvert and are blocking inlet</li> </ul> | <ul style="list-style-type: none"> <li>- Significant erosion found</li> <li>- Tree debris blocking access to outlet</li> <li>- Unable to confirm culvert location or size</li> <li>- Slope has partially eroded over outlet</li> <li>- Recommend stabilization of outfall</li> </ul> |

Inlet looking southeast

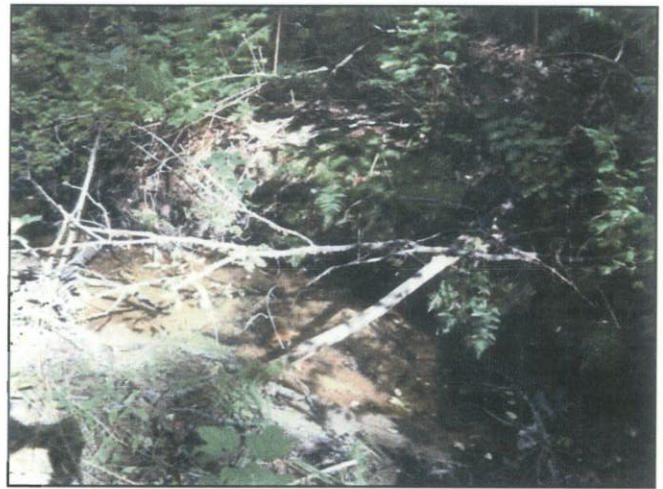
Upstream inlet ditch looking northwest

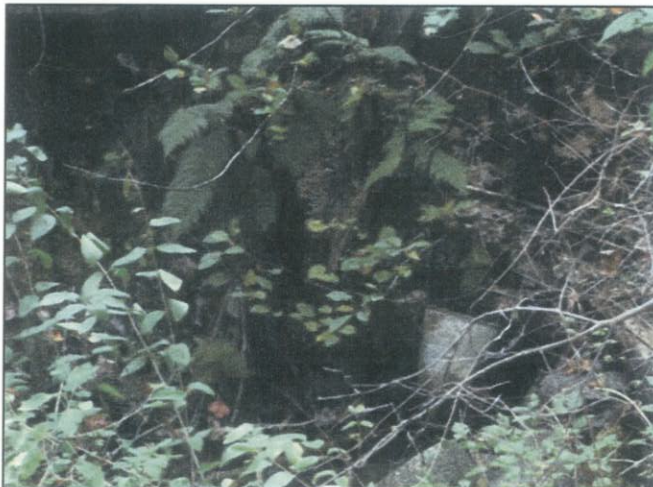
| INSPECTION #13 | Inlet | Outlet |
|---|---|--|
| <b>Condition of Culvert:</b> | Adequate | Poor due to erosion |

Outlet looking northwest

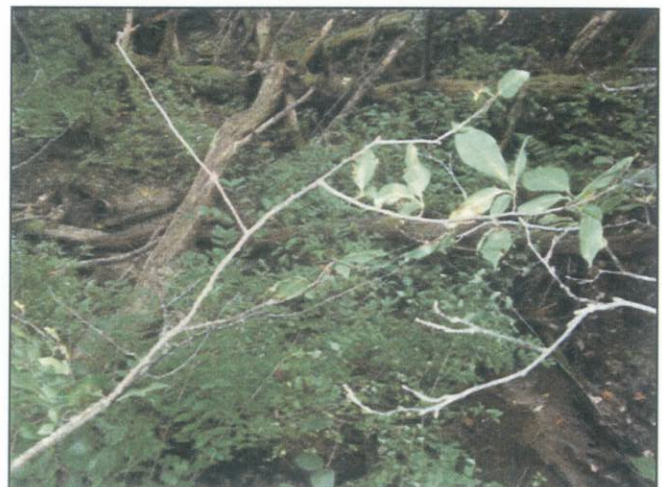
Outlet outfall looking northeast

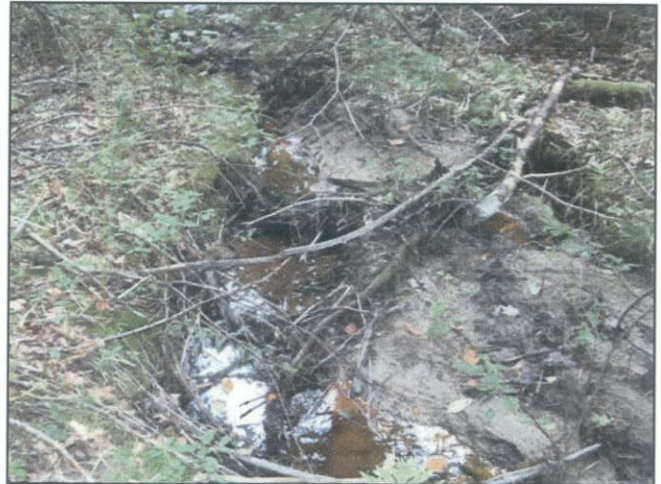
| INSPECTION #14 | Inlet | Outlet |
|---|--|---|
| <b>General Comments:</b> | - Tree debris/trash at inlet should be removed | - Erosion could be remedied with some stabilization such as riprap |

Inlet ditch looking northwest

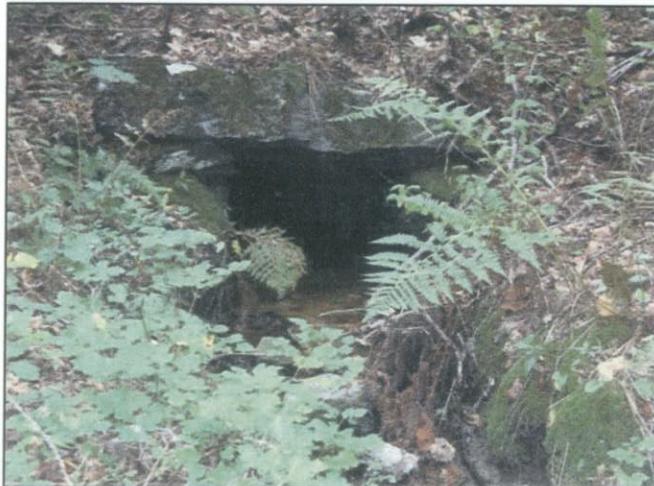
| INSPECTION #14 | Inlet | Outlet |
|---|--|---|
| <b>Sedimentation:</b> | 6-inches | 18-inches |

Outlet looking northwest

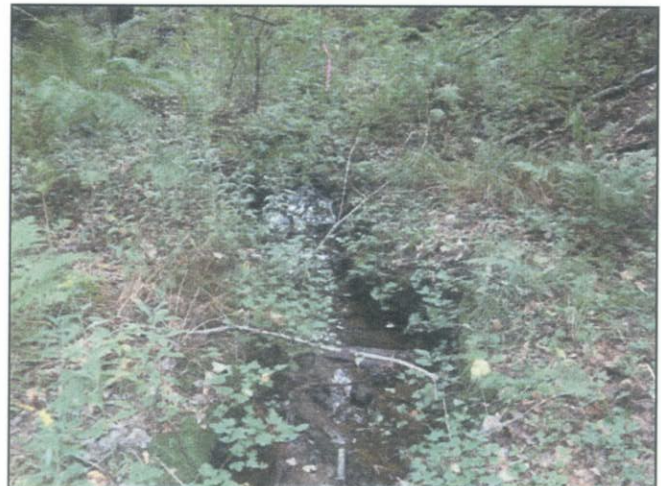
Outlet outfall looking southeast

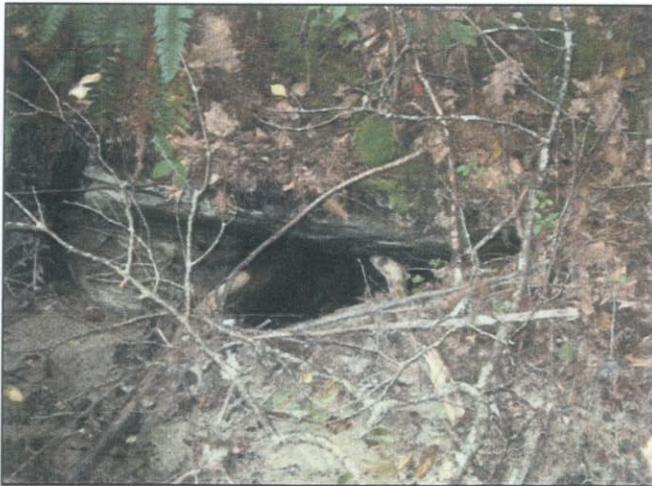
| INSPECTION #15 | Inlet | Outlet |
|---|--|--|
| <b>Condition of Culvert:</b> | Poor – eroded inlet banks | Adequate |
| <b>General Comments:</b> | <ul style="list-style-type: none"> <li>- Slope has eroded onto inlet and covered what looks like an existing granite box culvert</li> <li>- Unable to confirm existing culvert conditions</li> </ul> | <ul style="list-style-type: none"> <li>- Downstream tree debris in channel below outlet is blocking outflow</li> </ul> |

Potential inlet looking southeast

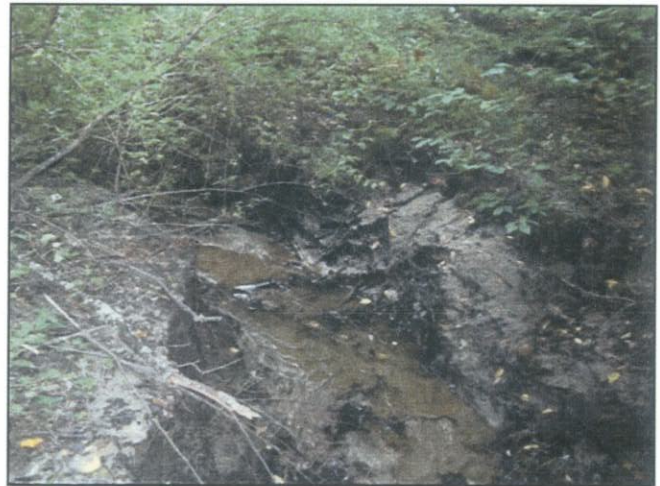
Potential inlet ditch looking north

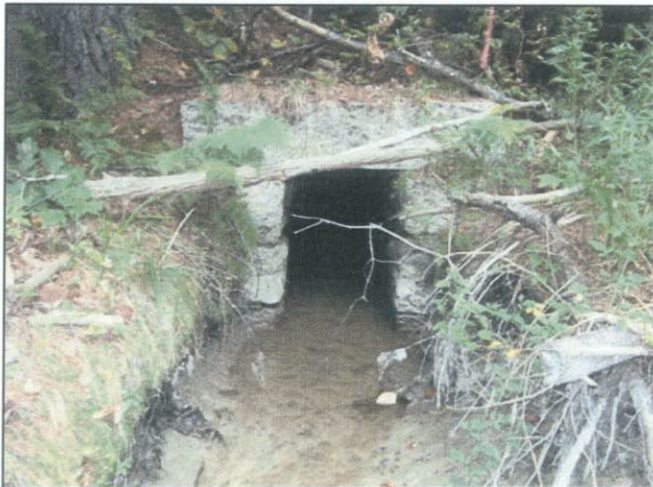
Outlet looking northwest

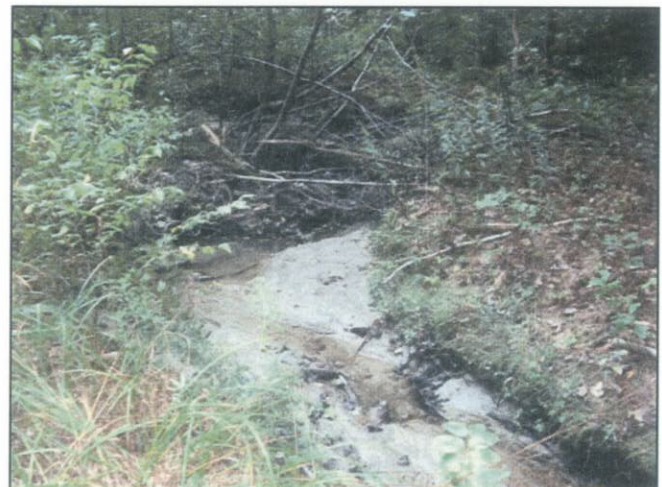
Outlet outfall looking southeast

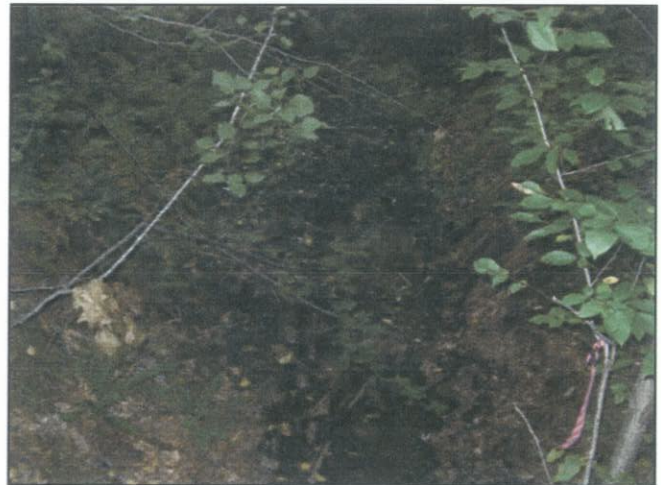
| INSPECTION #16 | Inlet | Outlet |
|---|--|--|
| <b>Condition of Culvert:</b> | Poor due to blocked inlet | Poor due to eroded slopes and debris |

Potential inlet ditch looking north

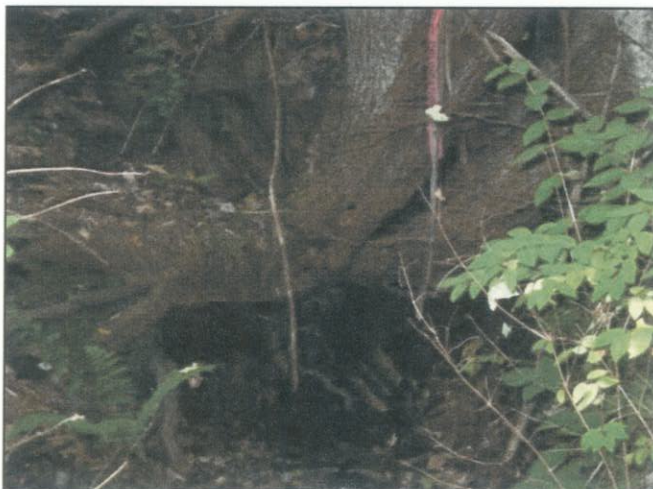
Potential outlet looking northwest

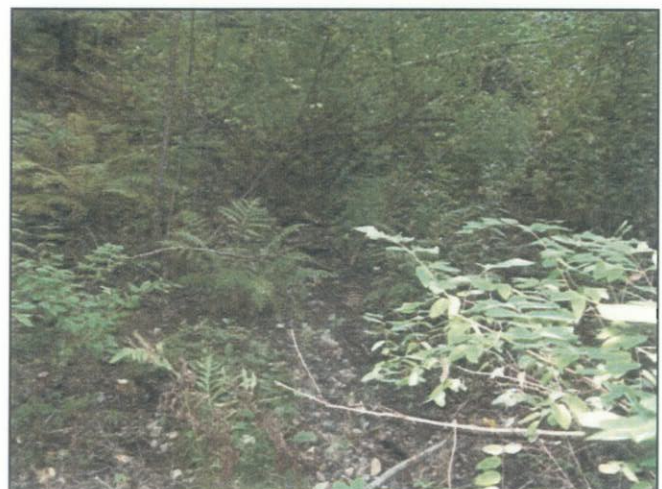
Potential outlet outfall looking southeast

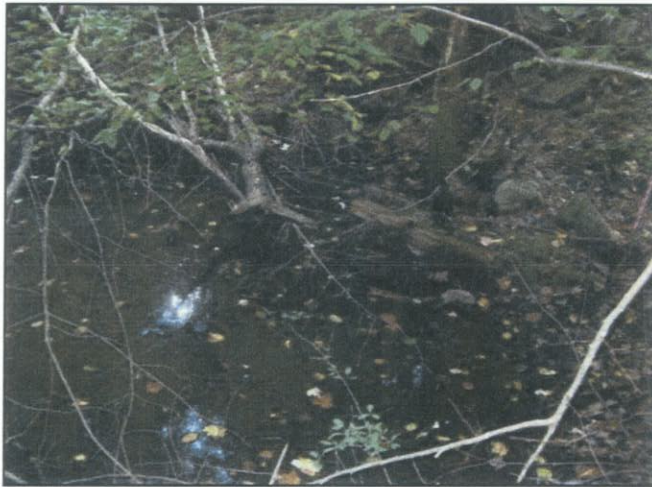
| INSPECTION #17 | Inlet | Outlet |
|---|--|---|
| <b>Condition of Culvert:</b> | Unknown – obscured by eroded slopes | Obscured by eroded slopes |
| <b>General Comments:</b> | <ul style="list-style-type: none"> <li>- Pipe/culvert not found</li> <li>- Could be submerged in water</li> <li>- Tree debris exists as well</li> <li>- Remnants of granite stone present</li> </ul> | <ul style="list-style-type: none"> <li>- Pipe/culvert not found</li> <li>- Could be submerged in water</li> </ul> |

Potential inlet looking east

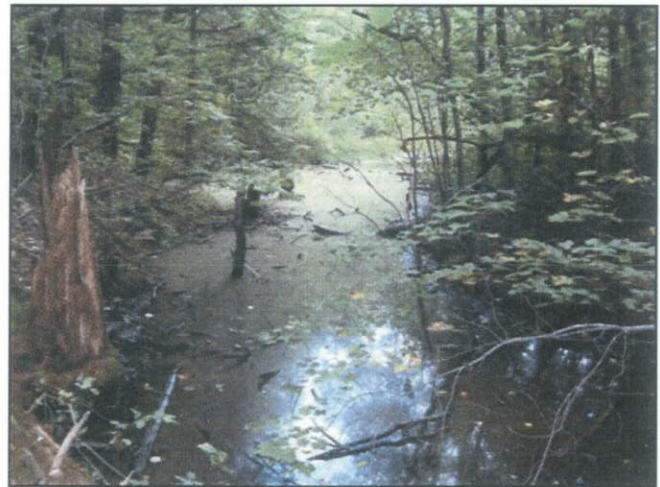
Potential inlet collection area looking northwest

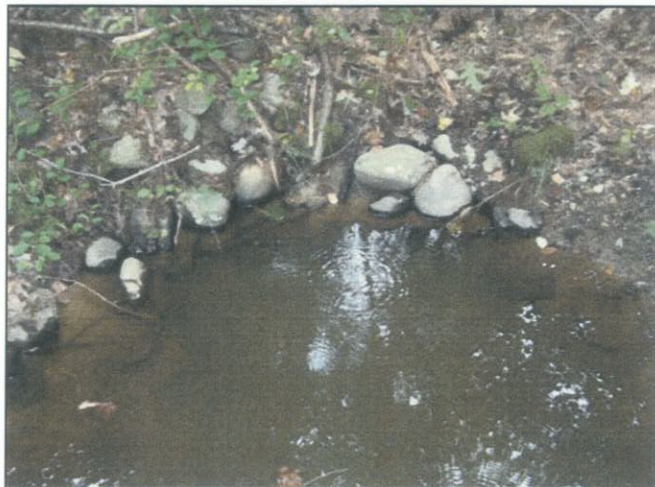
Potential outlet looking northwest

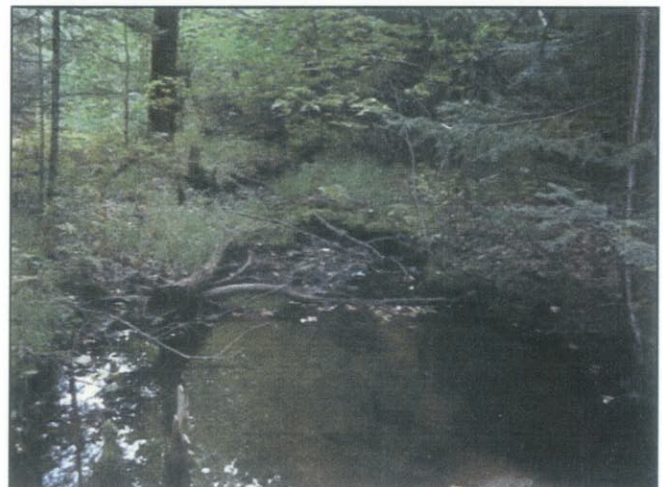
Potential outlet outfall looking southeast

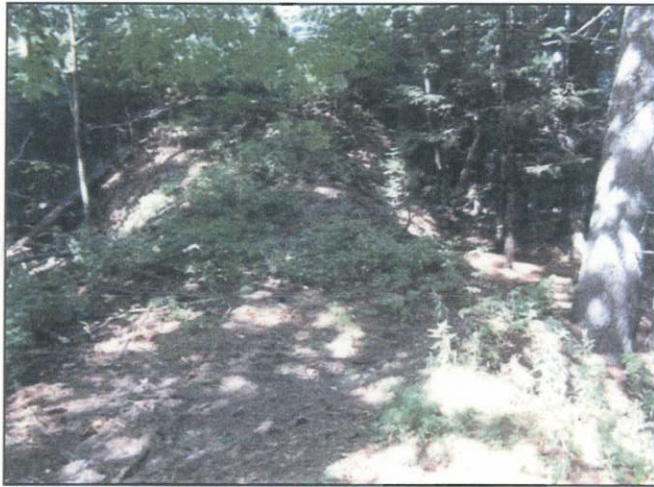
| INSPECTION #18 | Inlet | Outlet |
|---|---|---|
| <b>General Comments:</b> | <ul style="list-style-type: none"> <li>- Culvert provides access for abutting residence to existing trail. This culvert does not pass beneath trail.</li> <li>- Minor flow</li> <li>- Tree debris blocking inlet</li> </ul> | <ul style="list-style-type: none"> <li>- Small flow (less than 1-inch)</li> <li>- Outlet 6-inches above ground</li> </ul> |

Access to abutting residence over culvert looking northwest from existing trail

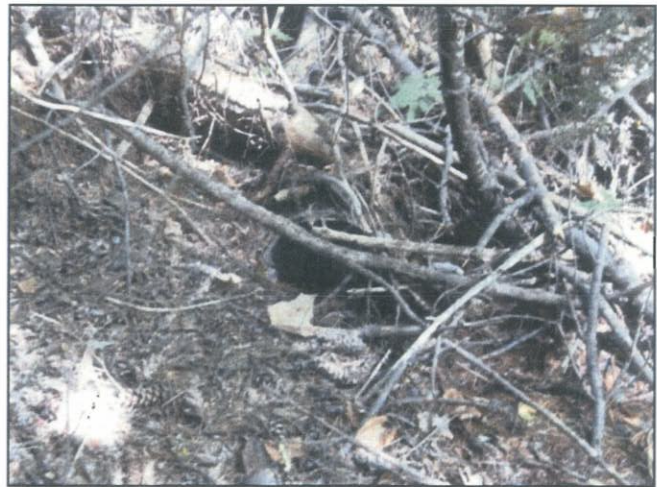
| INSPECTION #18 | Inlet | Outlet |
|---|---|---|
| <b>Condition of Culvert:</b> | Eroded at bottom | Eroded at bottom |

Inlet looking northeast

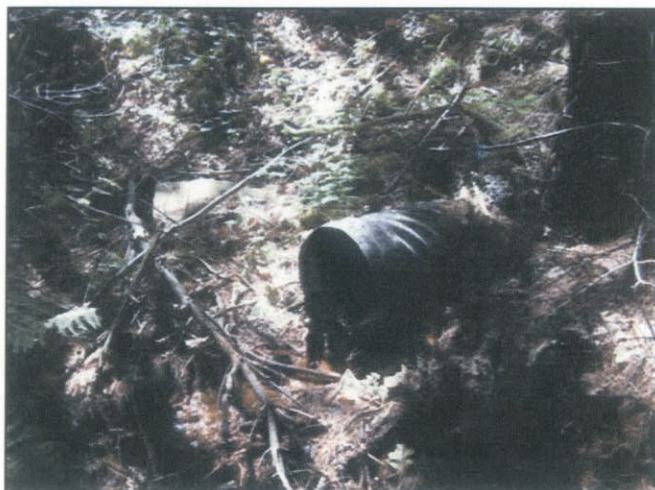
Outlet looking south
