**Culvert Inspection Reports**

DeLUCA-HOFFMAN ASSOCIATES, INC.  
CONSULTING ENGINEERS

**CULVERT INSPECTION REPORT**  
EASTERN TRAIL EXTENSION PROJECT  
From Milliken Mills Road in Old Orchard Beach to  
Thornton Academy in Saco

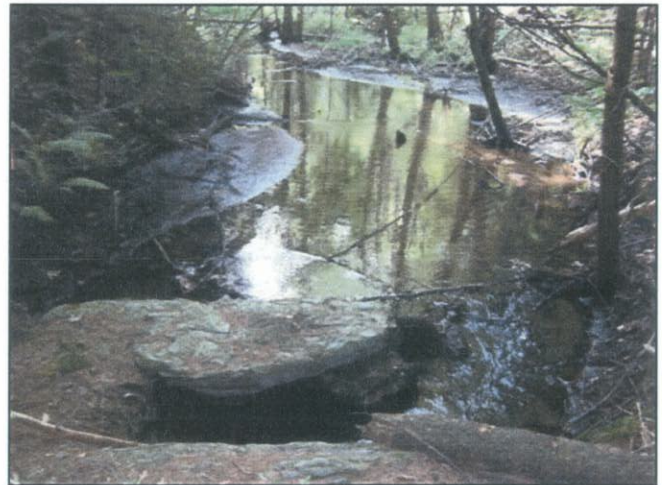
| INSPECTION #19 | Inlet | Outlet |
|---|--|---|
| <b>Condition of Culvert:</b> | Poor | Good |

Inlet looking south

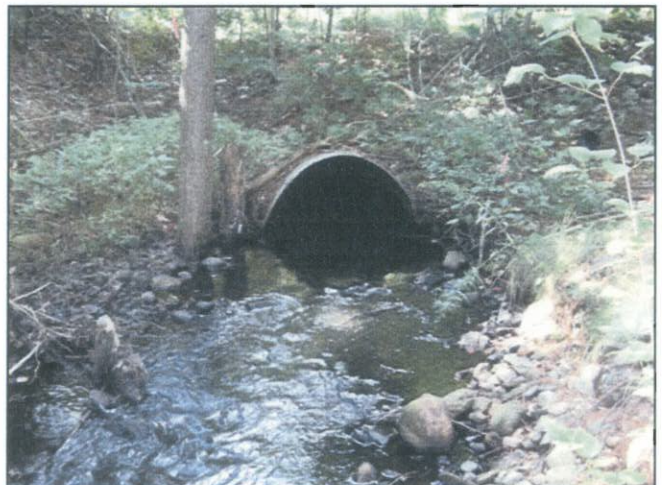
Outlet looking south

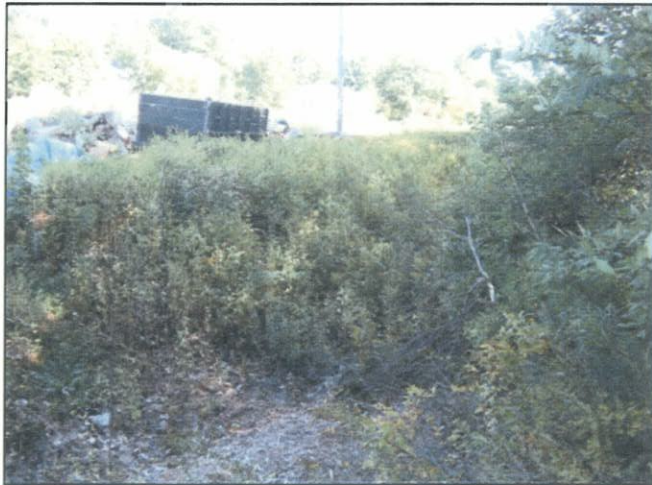
| INSPECTION #20 | Inlet | Outlet |
|---|---|--|
| <b>General Comments:</b> | <ul style="list-style-type: none"> <li>- No culvert found however based on downstream conditions it appears one exists here, may be plugged/buried</li> <li>- No flowing water found</li> <li>- Vegetated ditch filled with brush/grass debris</li> </ul> | <ul style="list-style-type: none"> <li>- No culvert found, may be plugged/buried</li> <li>- Water seeps out of ground (less than 2" deep)</li> <li>- Water flows through ditch to Milliken Mills Pond</li> </ul> |

Potential inlet looking northeast

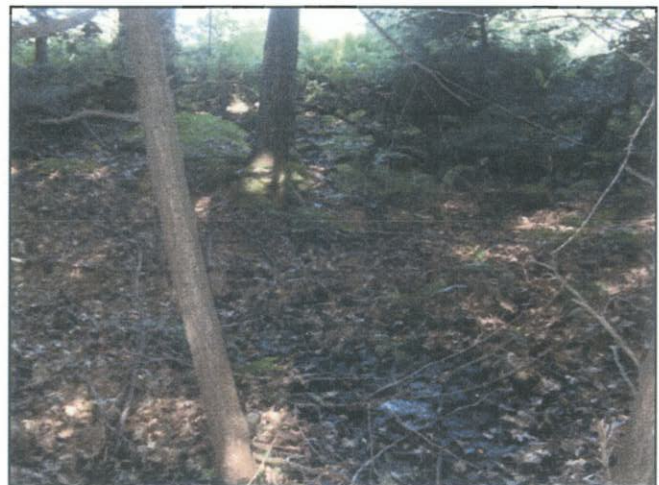
Potential outlet outfall looking west

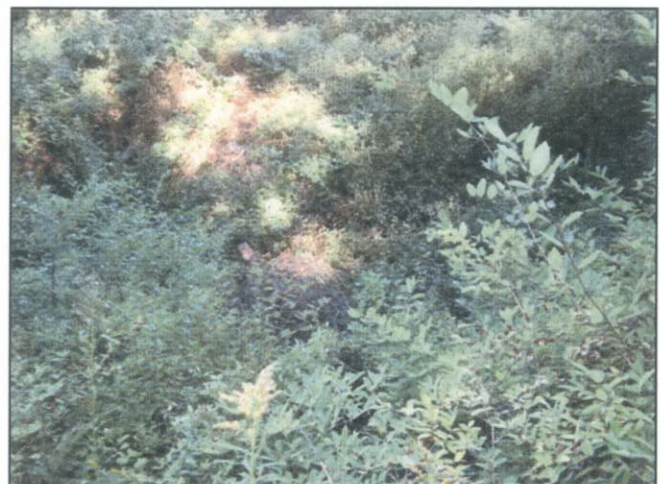
Inlet ditch looking west from proposed Trail

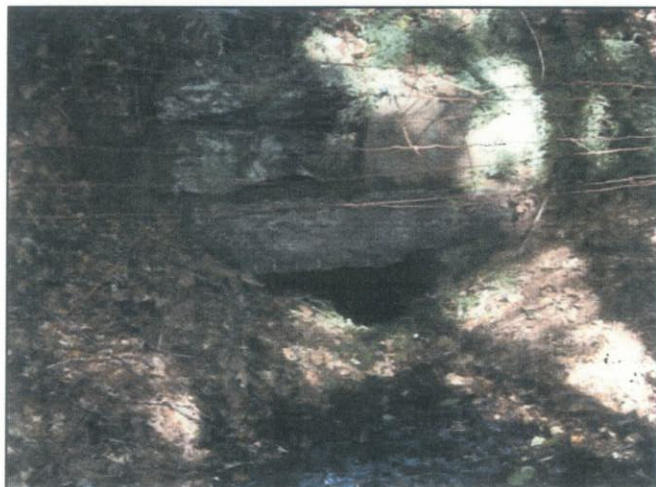
Outlet looking west

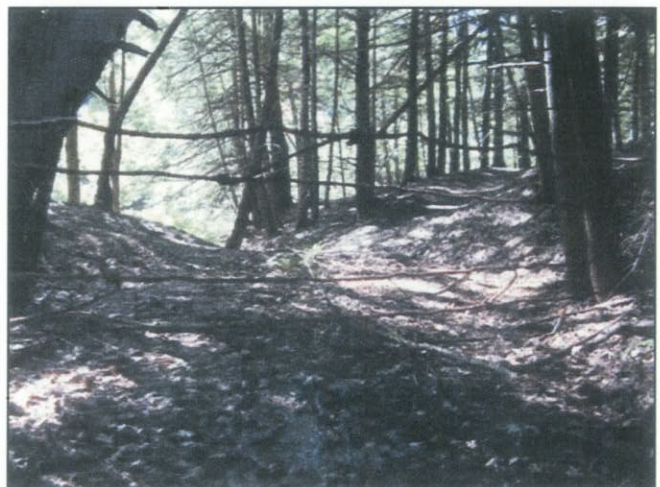
Outlet outfall looking east to Milliken Mills Pond
