Street Crossing Reports

TRAIL-STREET CROSSING REPORT
 EASTERN TRAIL MANAGEMENT DISTRICT – PIN 13340.00

**Trail Crossing Photos
Eastern Trail Management District
Old Orchard Beach and Saco
PIN 13340.00**

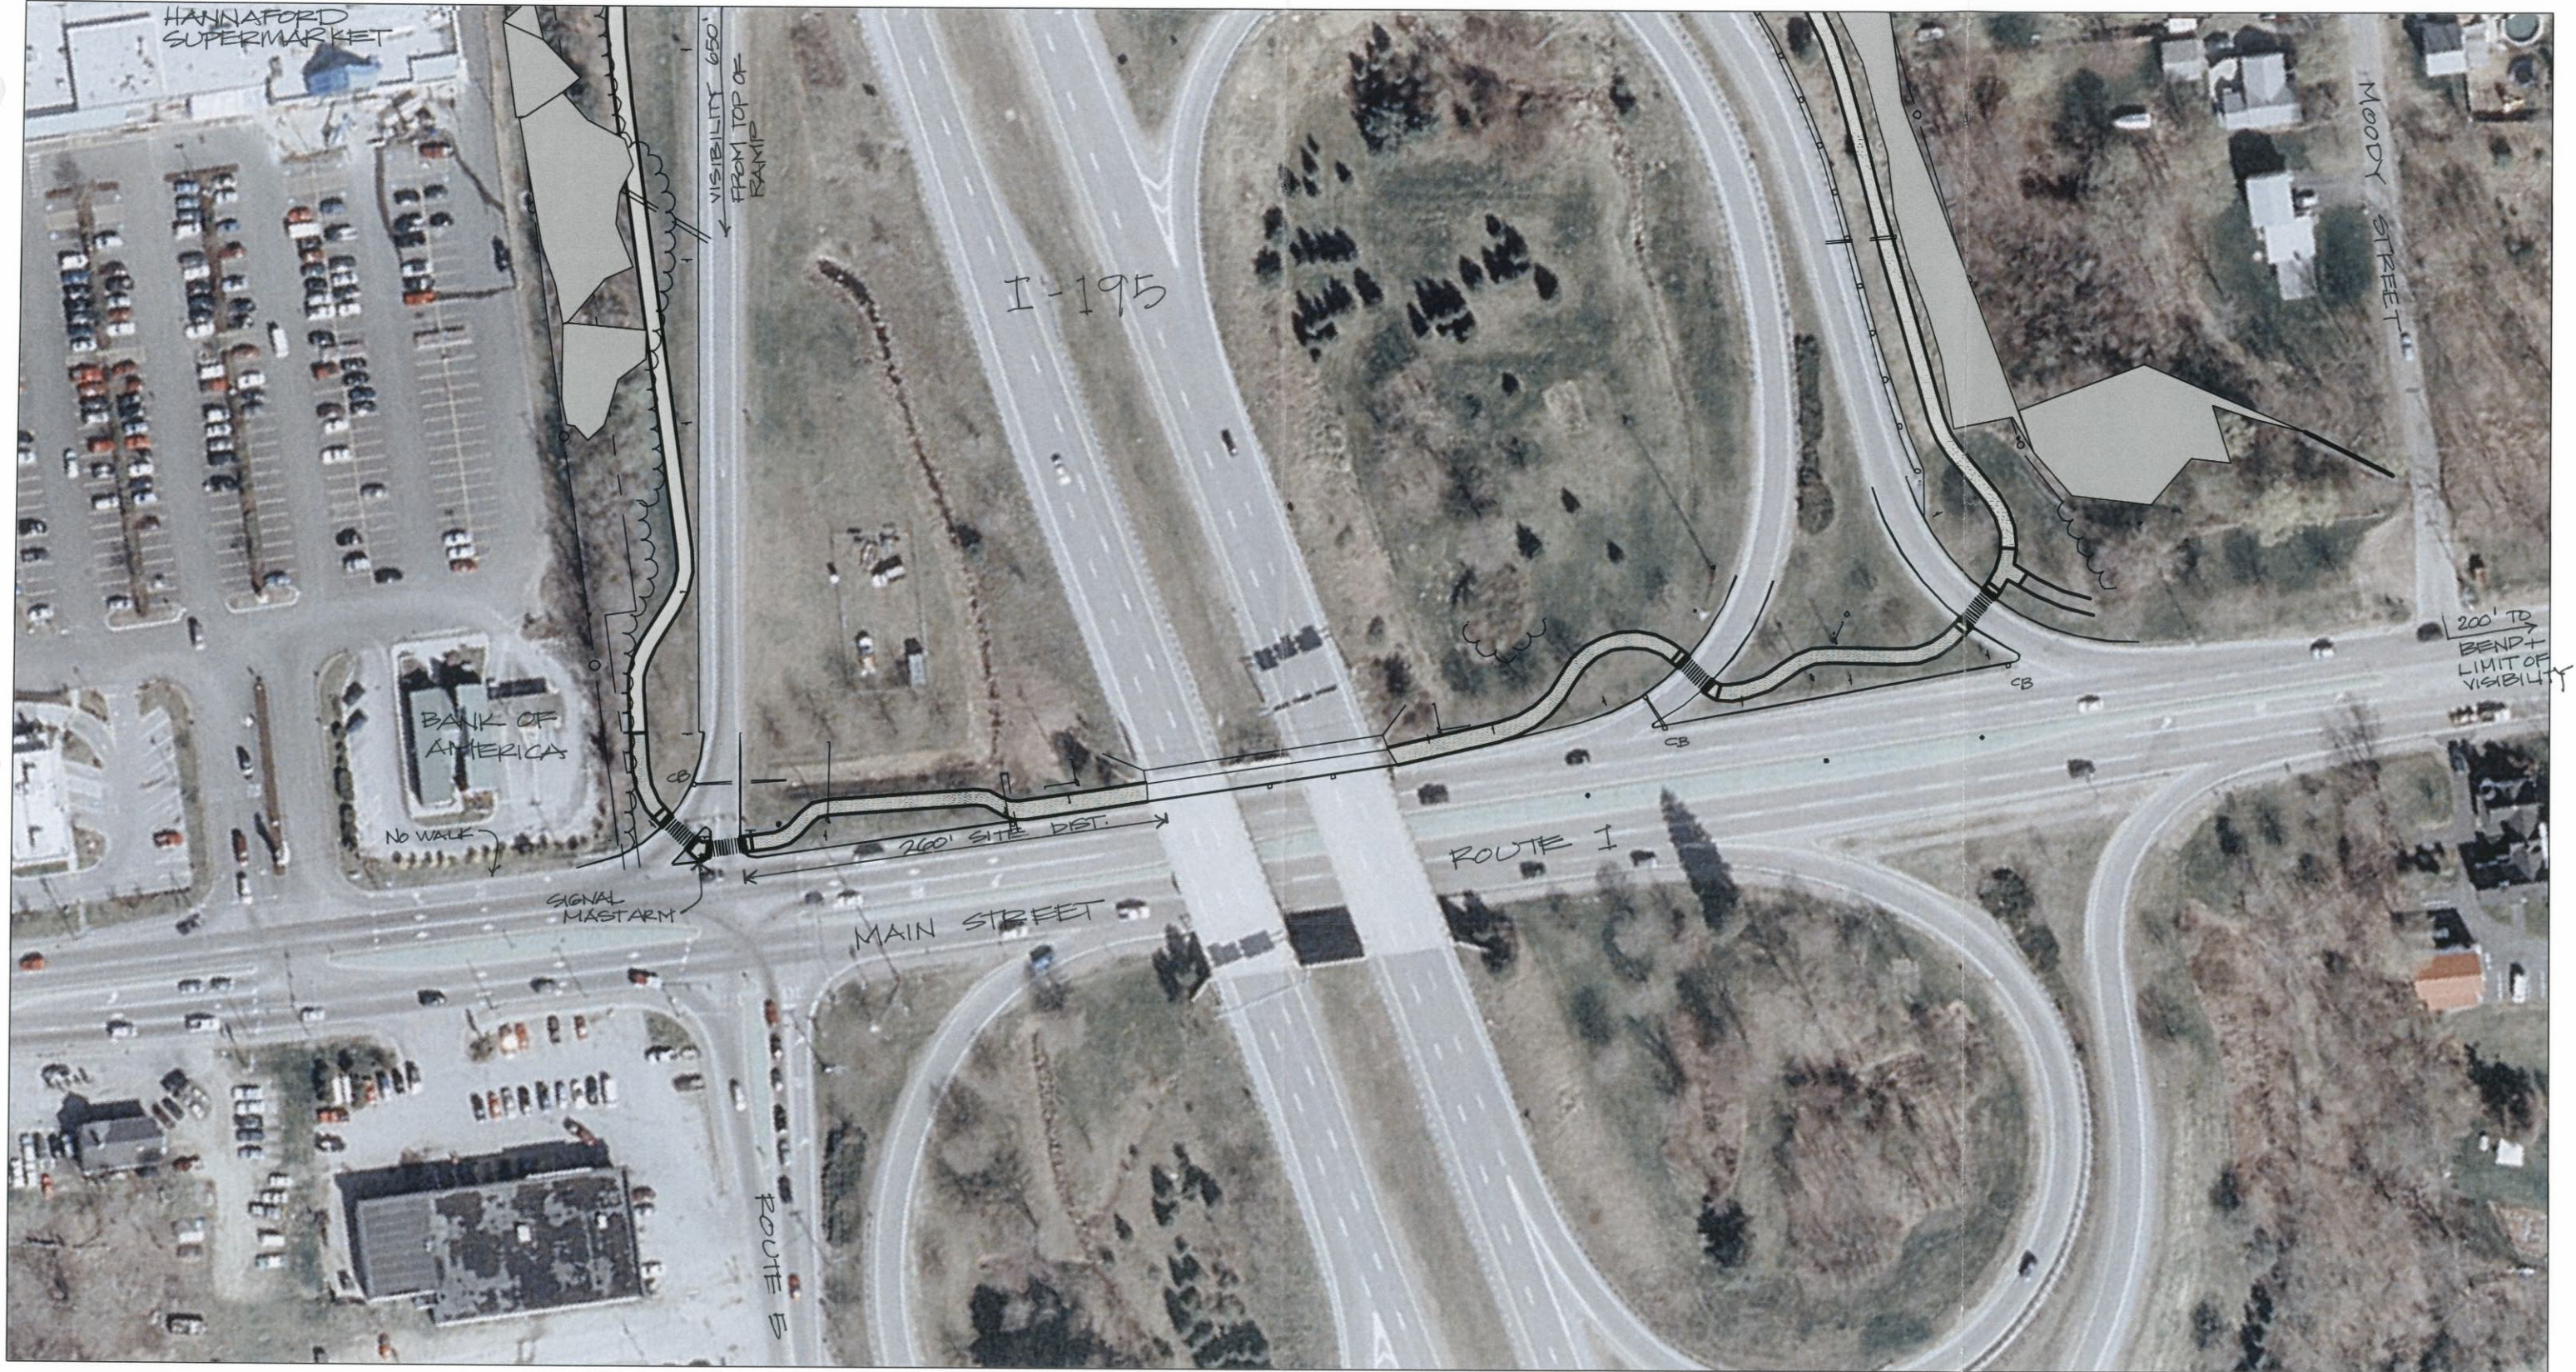
CROSSING SKETCH

Proposed trail alignment is parallel to U.S. Route 1 and crosses interstate access ramps. Incorporation of pedestrian signal phase recommended for trail crossing at ramp. Signage on ramp required to provide notice of crossing pedestrian movements.

- ALL VERTICAL GRANITE CURB, WEST SIDE OF ROAD
- RAISED CONCRETE ISLAND W/ MAST ARM, EAST BOUND OFF-RAMP
- OVERHEAD UTILITIES PARALLEL TO ROUTE 1, WEST SIDE

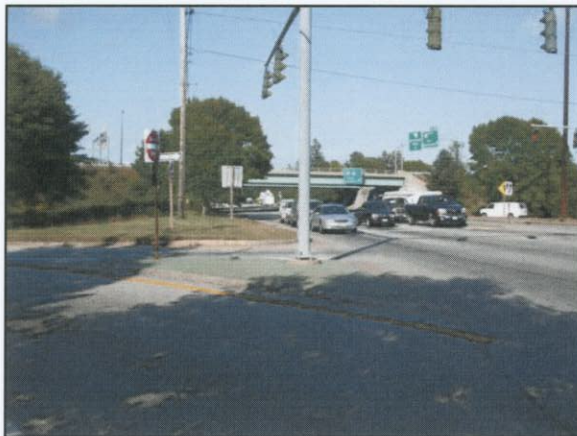
North View

NORTH	<u>260'</u>
EAST	<u>305'+</u>
SOUTH	<u>305'+</u>
WEST	<u>650' (from ramp)</u>

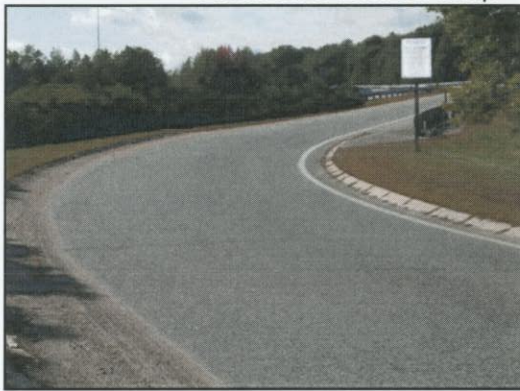
West view of on-ramp

There is a bermed area bordering the north edge of the I-195 on-ramp from Route 1. This grade requires modification to provide universal access to the ramped landing leading to the crosswalk. Curb ramps and pedestrian crossing signage are needed at each crossing.

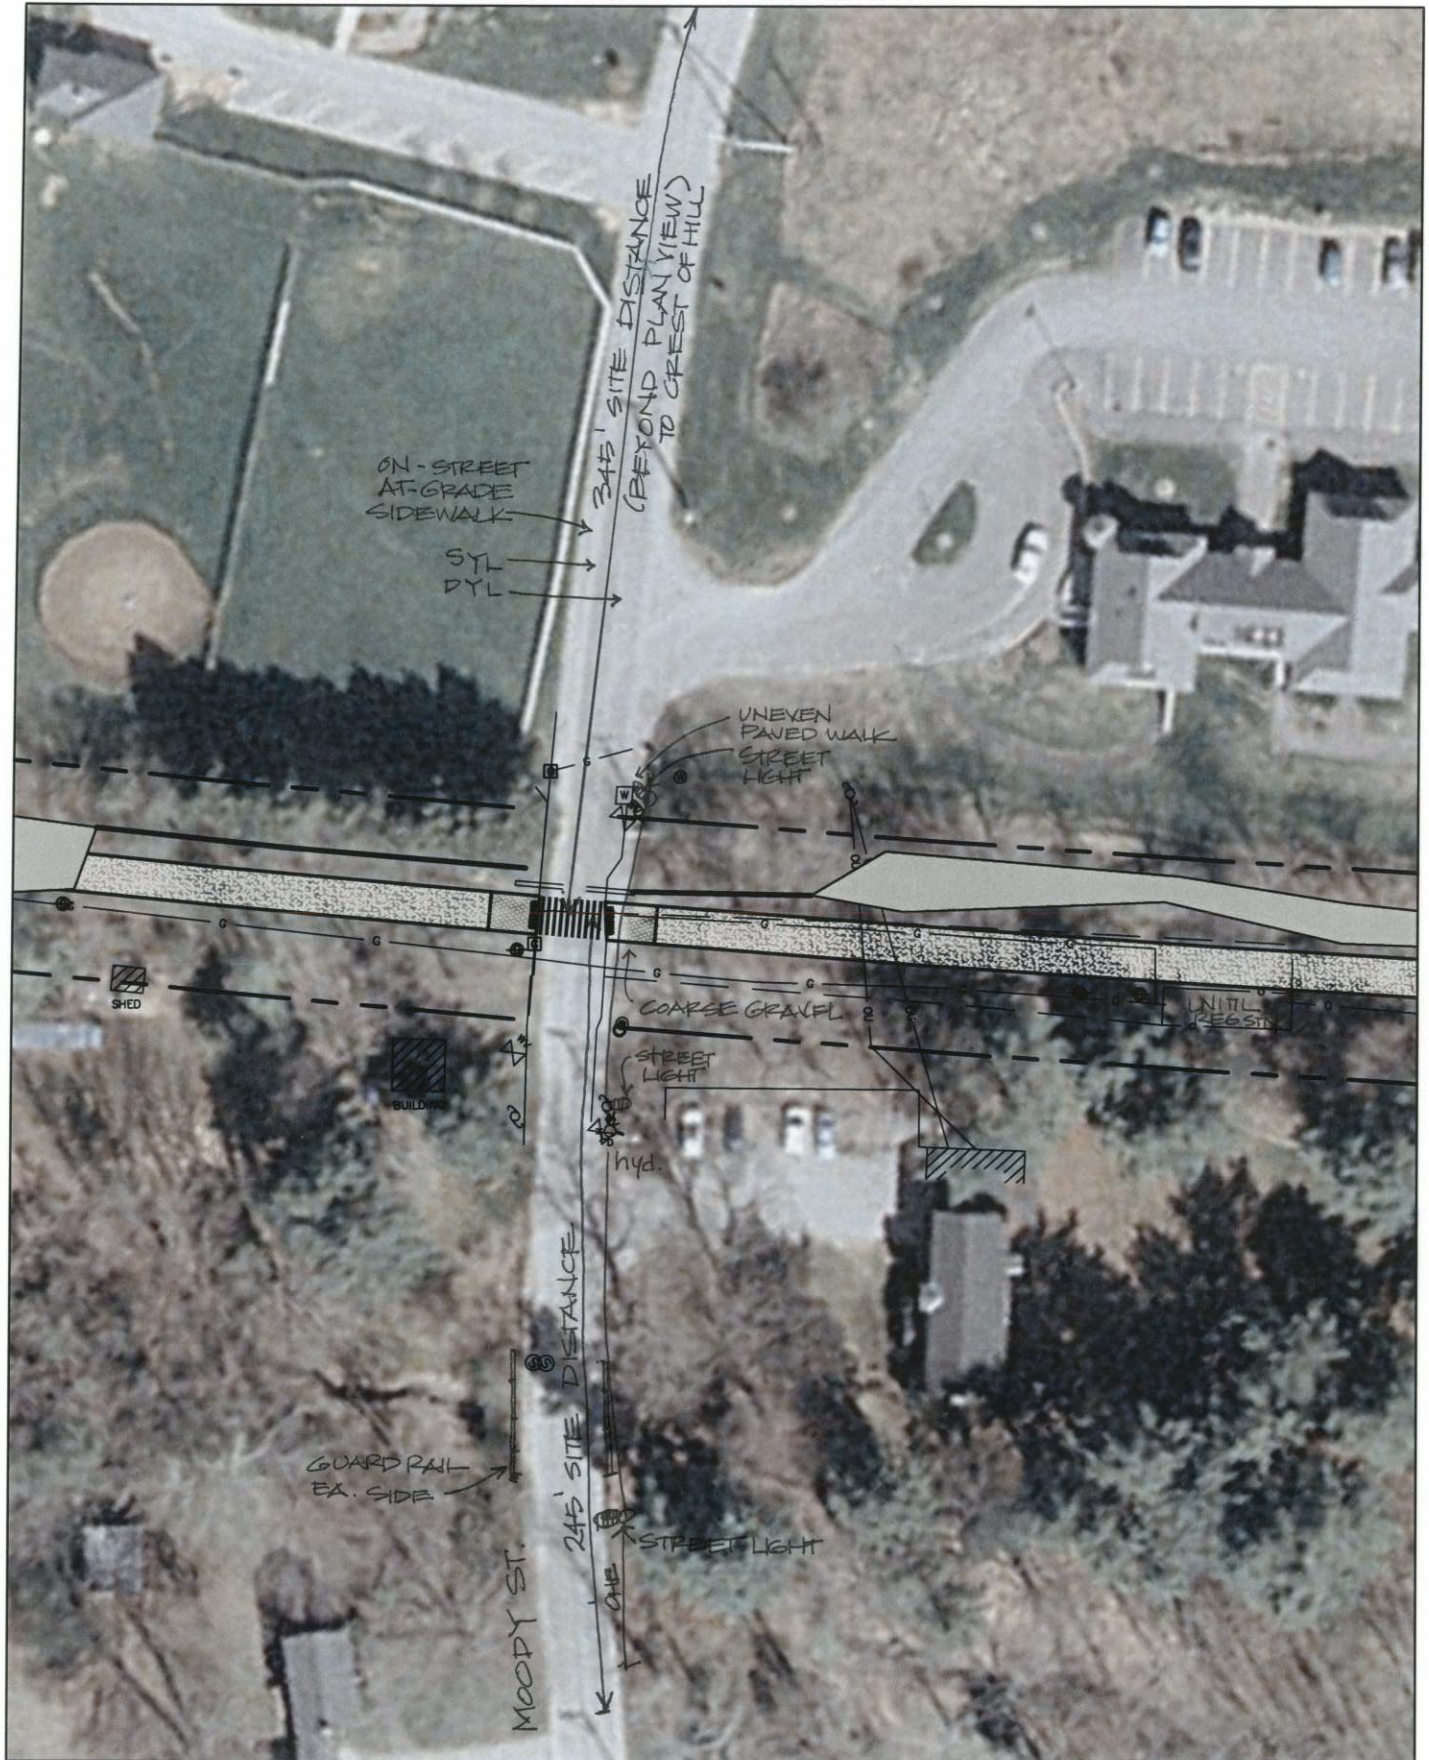
CROSSING SKETCH

Provide visual (painted) connection to painted sidewalk from Sweetser School. Moody Street is a relatively narrow street with moderate traffic flow to/from the Sweetser School located at the end of Moody Street west of this crossing.

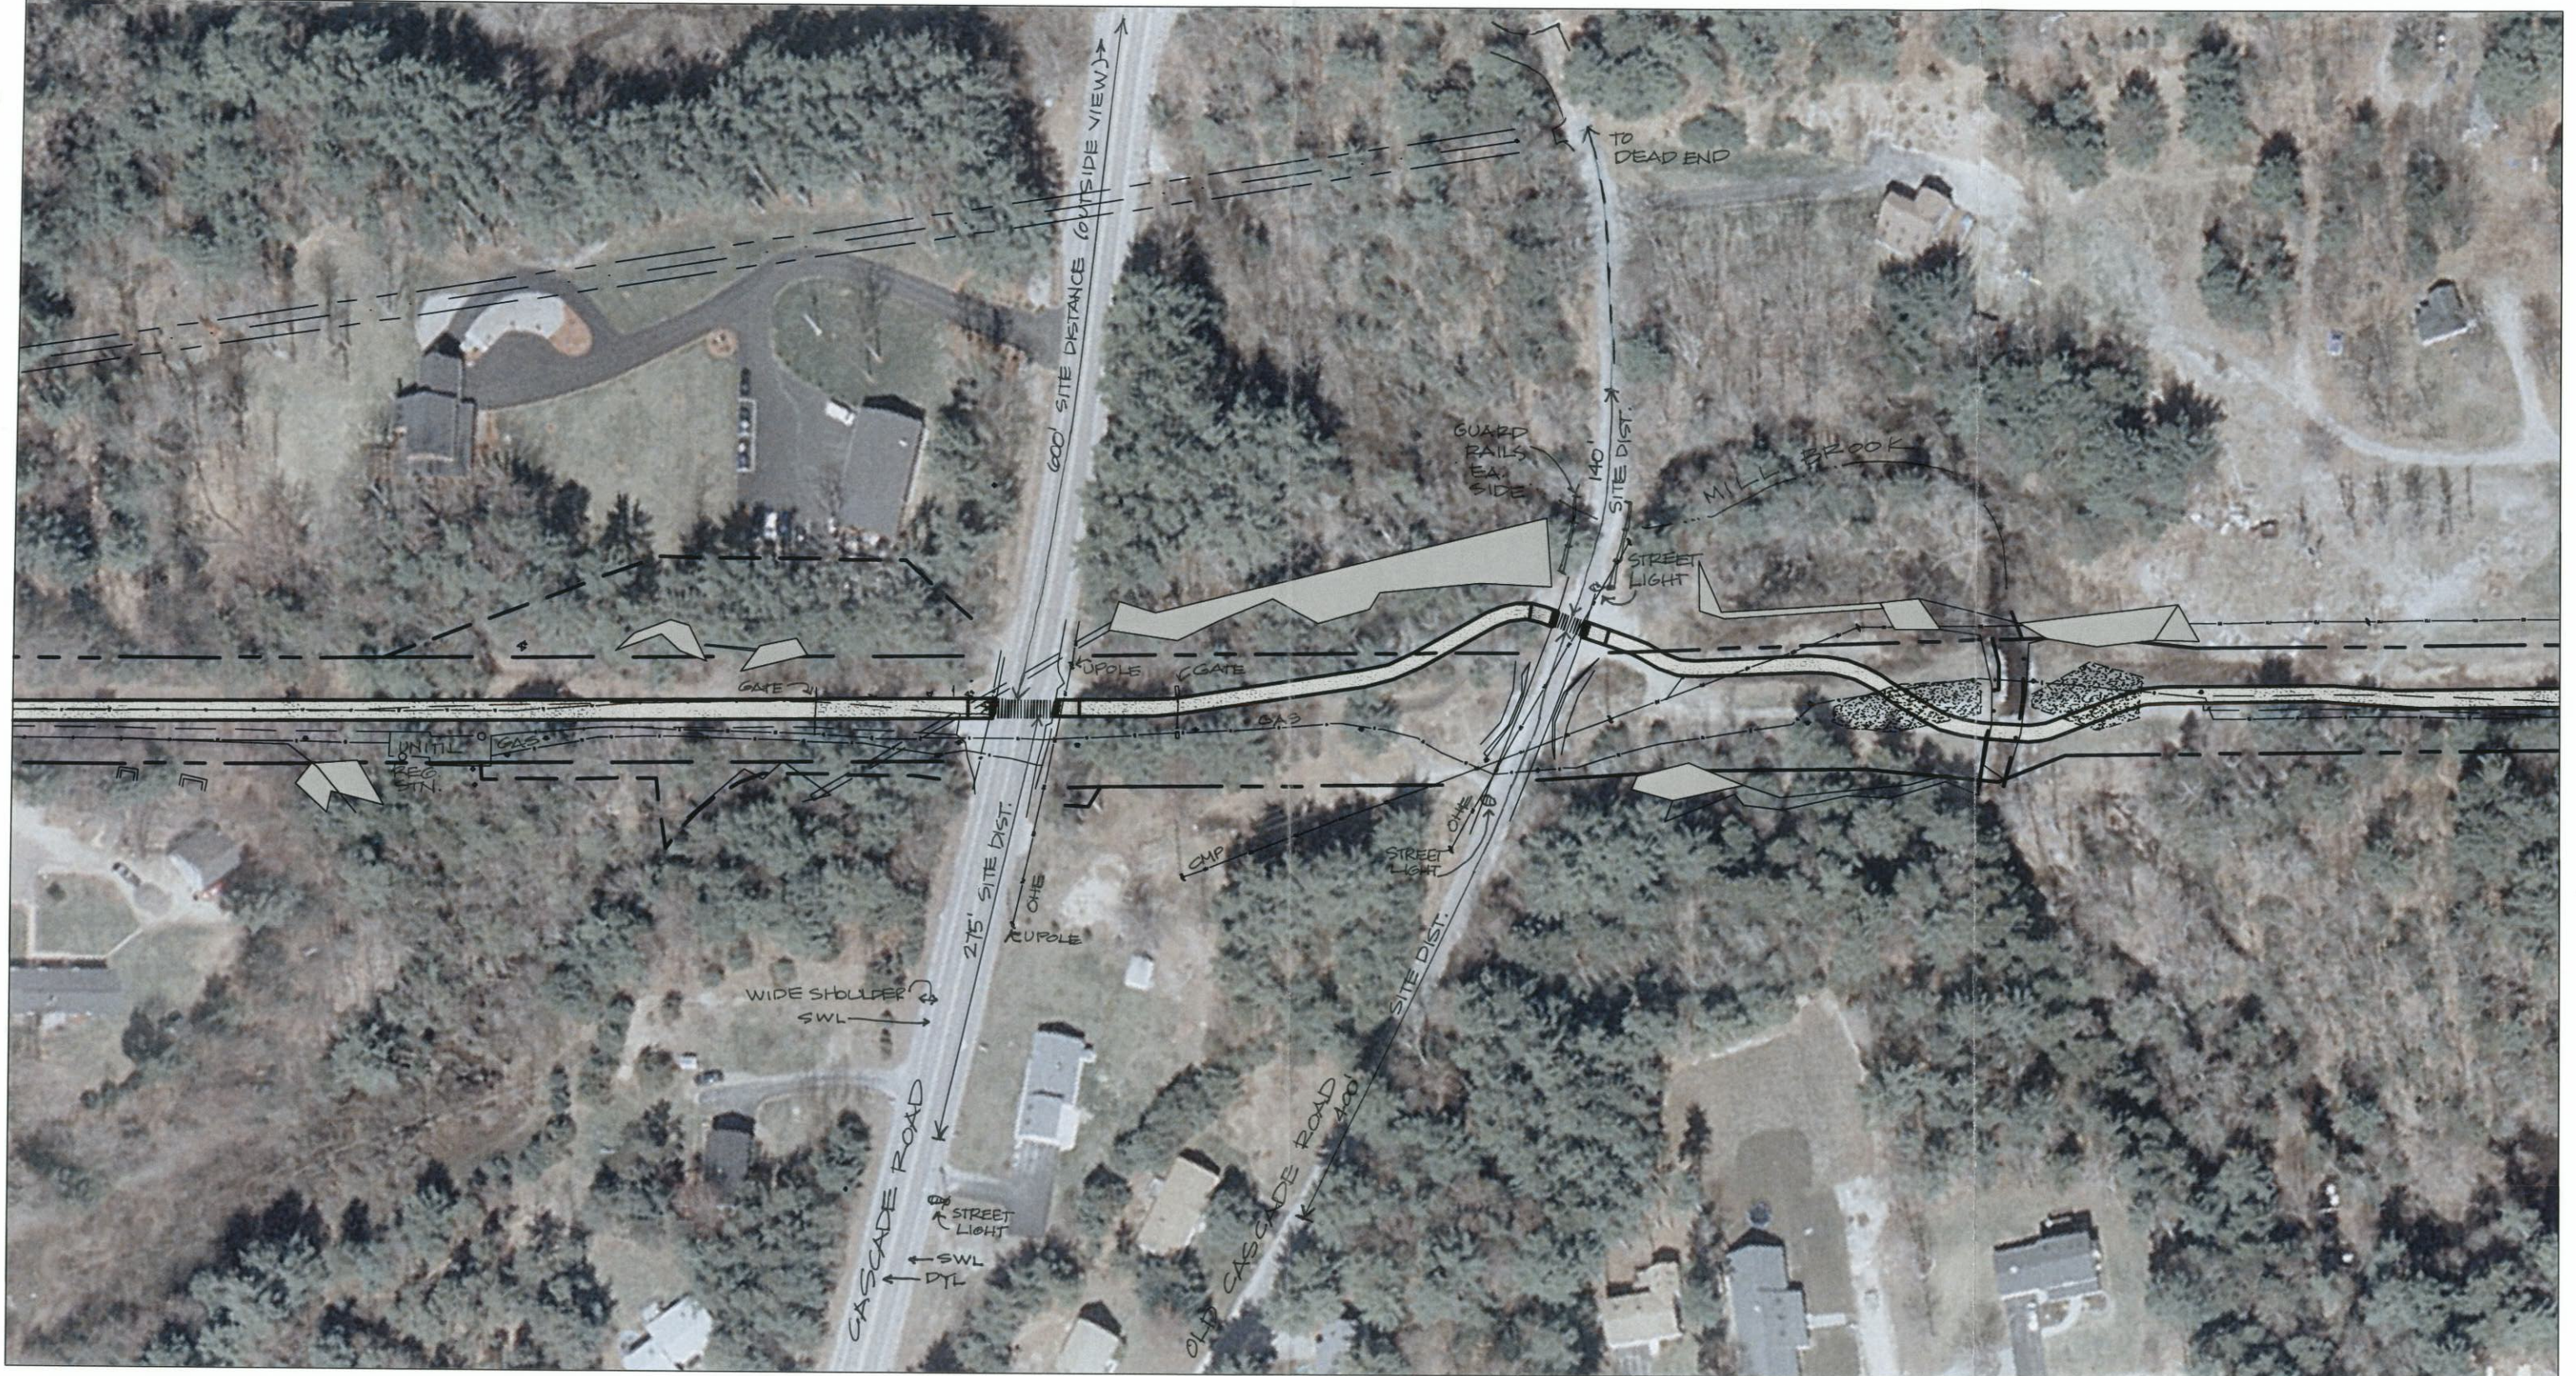
CROSSING SKETCH

Approach from east: Beyond 275', the vertical curve of the road limits visibility of objects at street-grade at the crossing; objects taller than 2-3 feet can be seen from a much greater distance from the east. Signage highly recommended.

Inside curve limits visibility of south trail segment as approached from the west. Removal of tree and vegetative undergrowth to open views of the intersection with the trail is recommended.

- EROSION FROM EXISTING PATH
- PAVEMENT CRACKED + SETTLED
- LOW AREAS NEAR + WEST OF RAILROAD ABUTMENTS

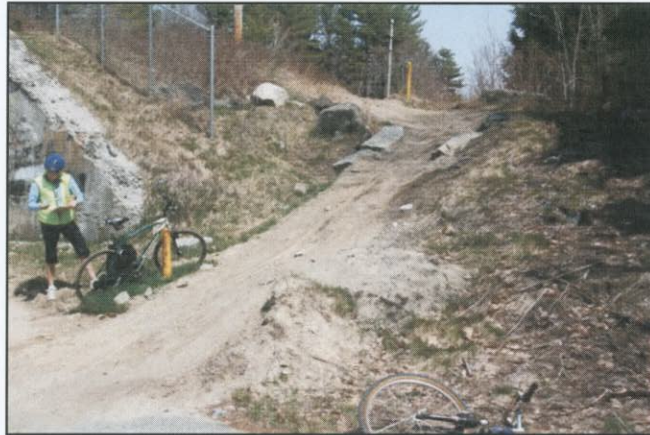
- Very lightly traveled dead end road, serves one single-family residence.
- Vertical alignment modifications necessary for street-grade crossing to accommodate universal accessibility guidelines.
- Existing bridge abutments limit visibility from west; removal may be an alternative to accommodate accessibility and increase visibility. Signage is recommended.
- Evidence of standing water and poor to moderate pavement conditions may require attention during final design.
- Crossing could be overhead pedestrian bridge; however, structural analysis of existing concrete abutments is required.

North view of eastern side of abutment

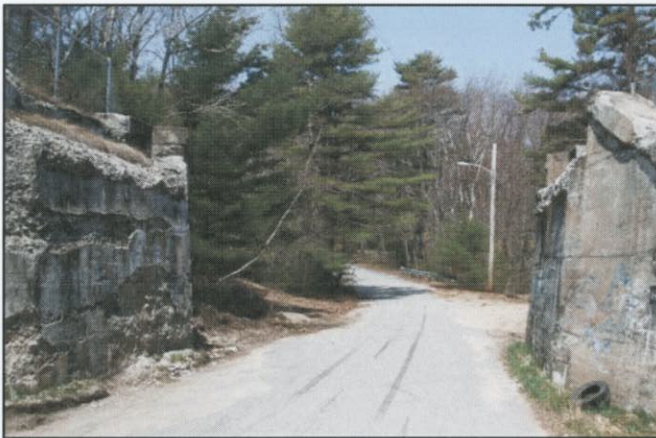
West View – Paths on west side of abutments obstructed

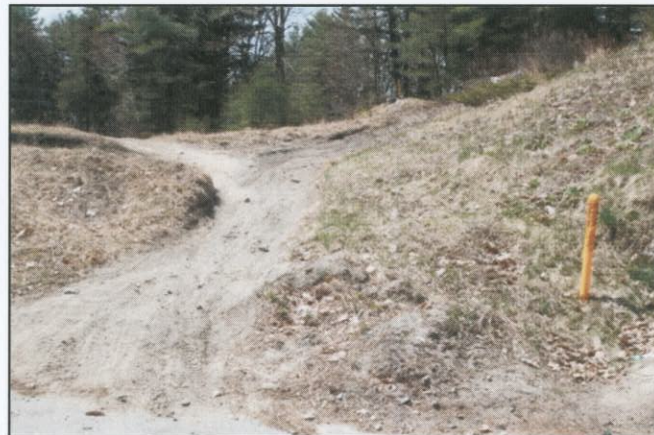
South view of eastern side of abutment; may not fall on ETMD property

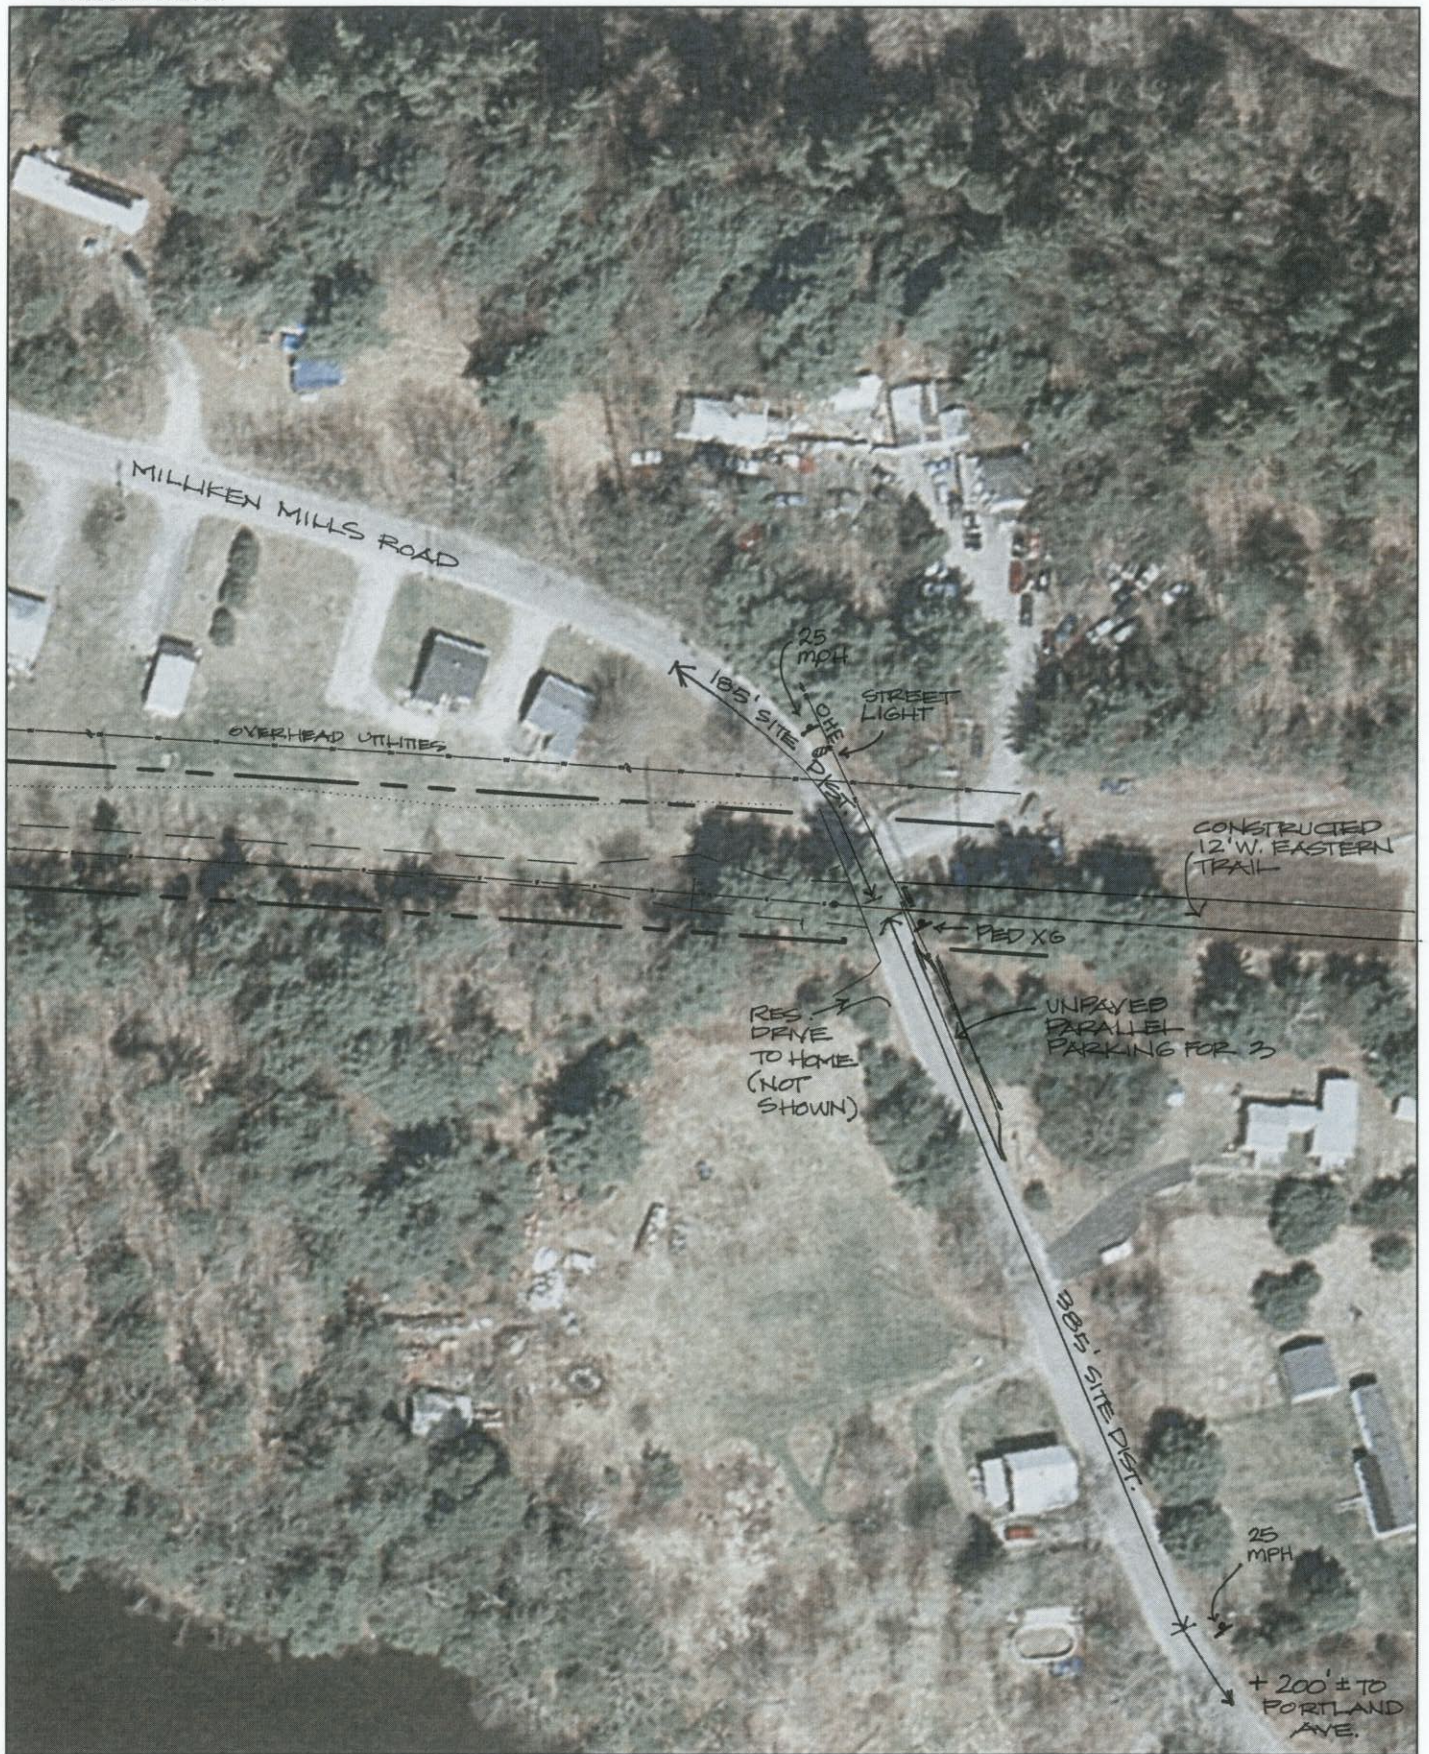
Inside curve limits visibility of south trail segment as one approaches from the west.

Visibility from south trail segment toward west is limited by the inside curve of the road and existing pines near trail.

- TRAIL AND ROADWAY
- PAVEMENT MARKINGS - DYL @ RD CENTER
- DRAINAGE FEATURES
- AERIAL UTILITIES - NORTH SIDE
- UNDERGROUND UTILITIES
- RESIDENTIAL / COMMERCIAL DRIVEWAYS
- PROPERTY FEATURES (WELLS, LEACHFIELDS)
- OTHERS PAVEMENT GOOD CONDITION

AT PARALLEL, ON STREET PKG:
 • ROOT DAMAGE & SLOPE EROSION

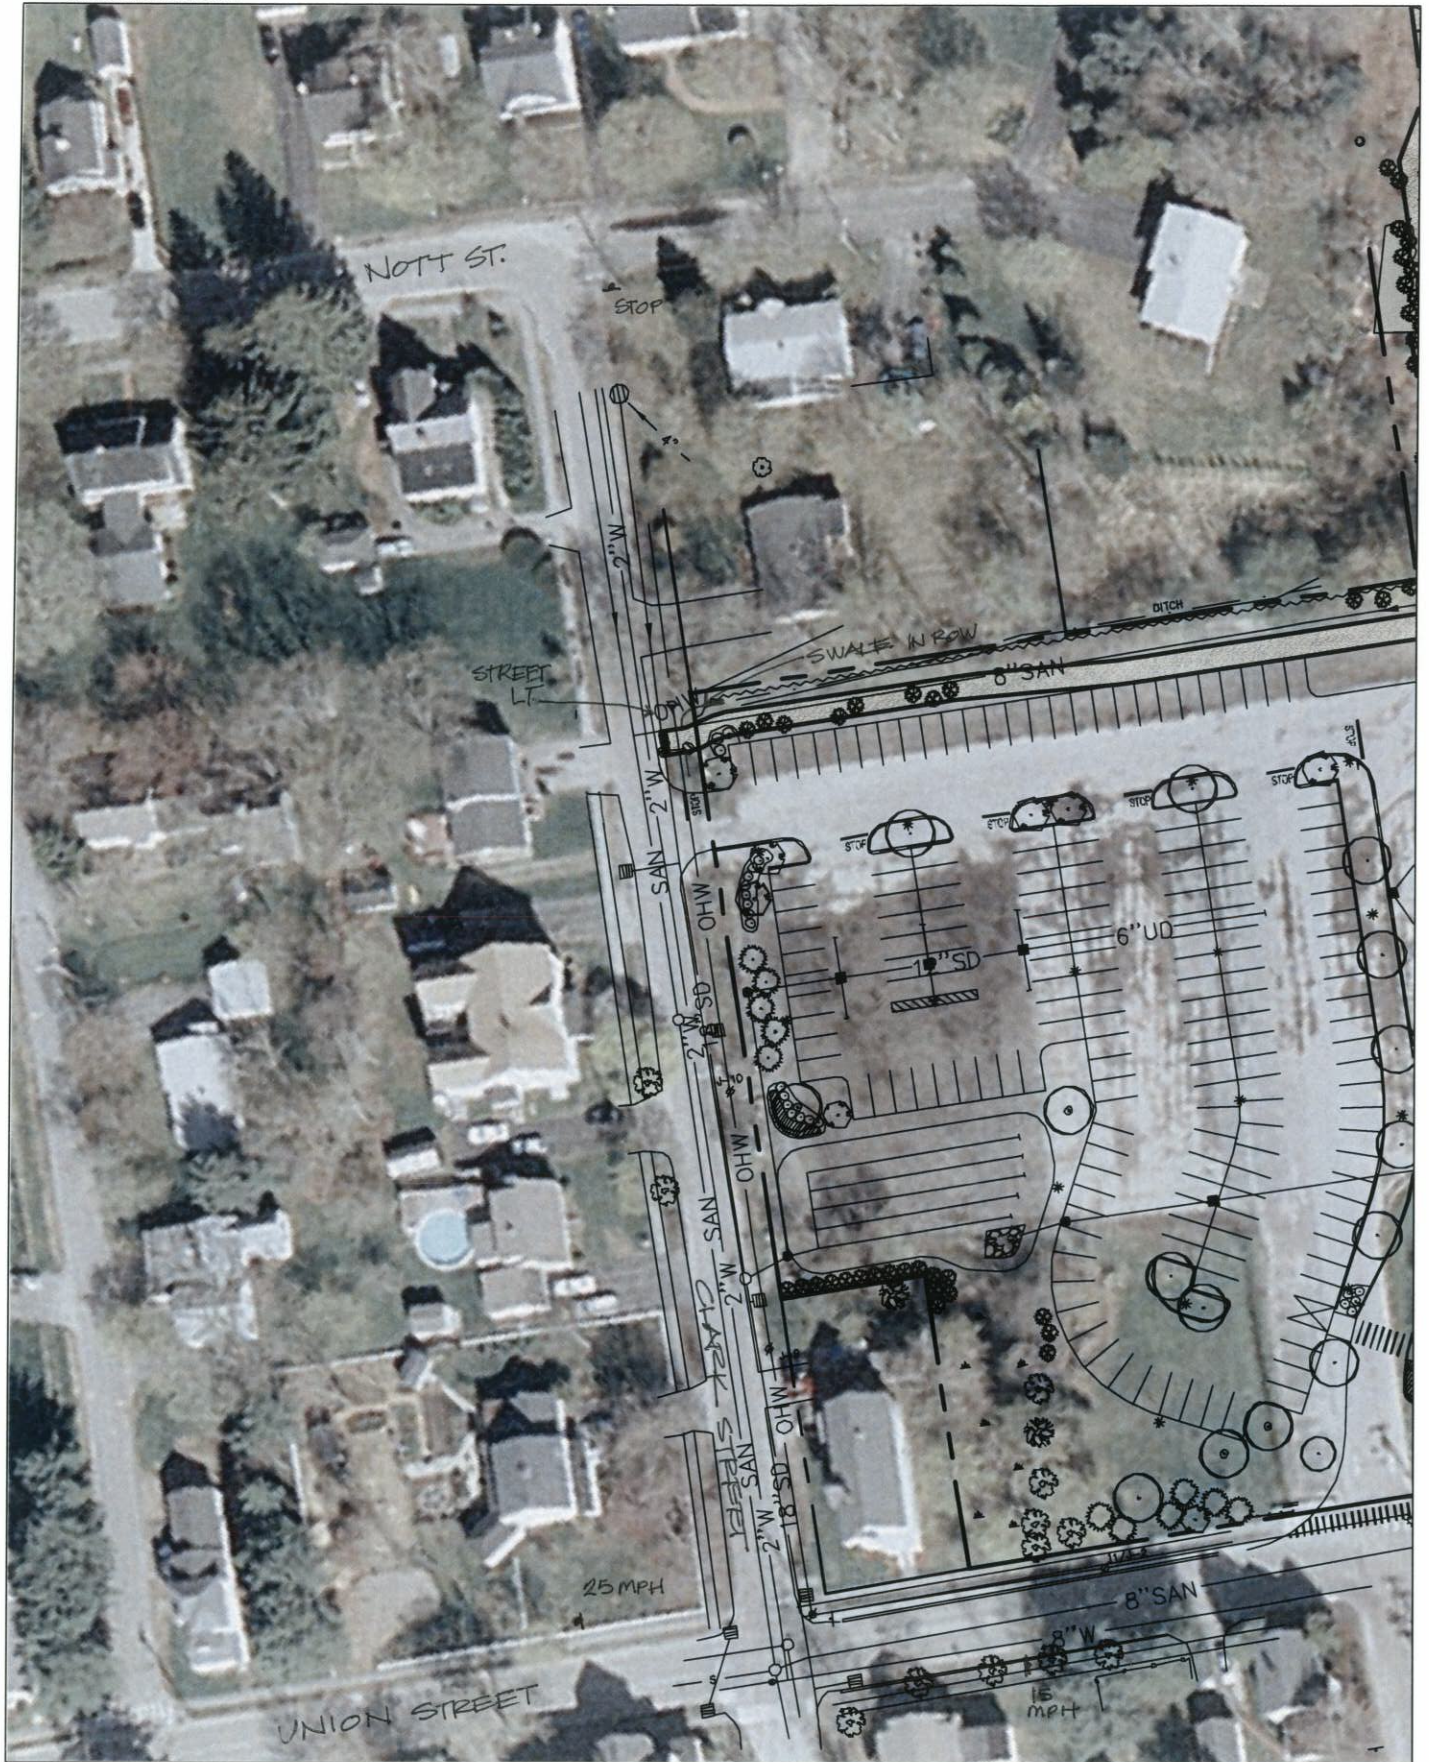
Trail crosses swale, grade descends to street elevation YES NO NA
