**Culvert Inspection Reports**

DeLUCA-HOFFMAN ASSOCIATES, INC.  
CONSULTING ENGINEERS

**CULVERT INSPECTION REPORT**  
EASTERN TRAIL EXTENSION PROJECT  
From Milliken Mills Road in Old Orchard Beach to  
Thornton Academy in Saco

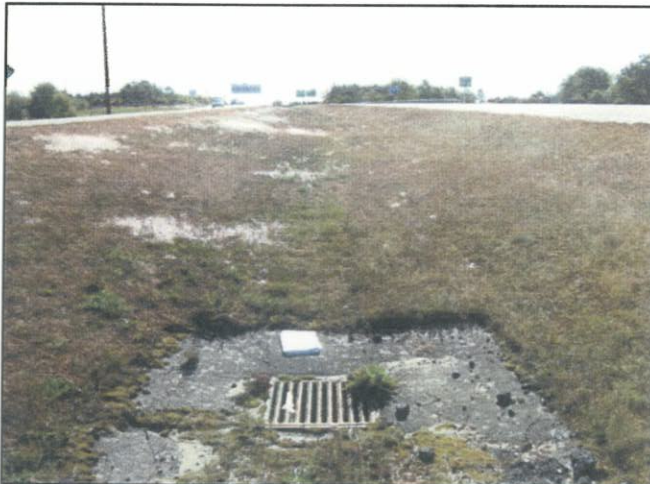
| INSPECTION #2 | Inlet | Outlet |
|---|---|---|
| <b>General Comments:</b> | <ul style="list-style-type: none"> <li>- CB not inspected as part of this review</li> <li>- CB has 6'x6' paved apron within ditch bottom</li> </ul> | <ul style="list-style-type: none"> <li>- RCP pipe chipped at top of pipe</li> <li>- Proposed Trail will cross over the outlet</li> <li>- Culvert extension may be required</li> </ul> |

Catch basin inlet looking southeast

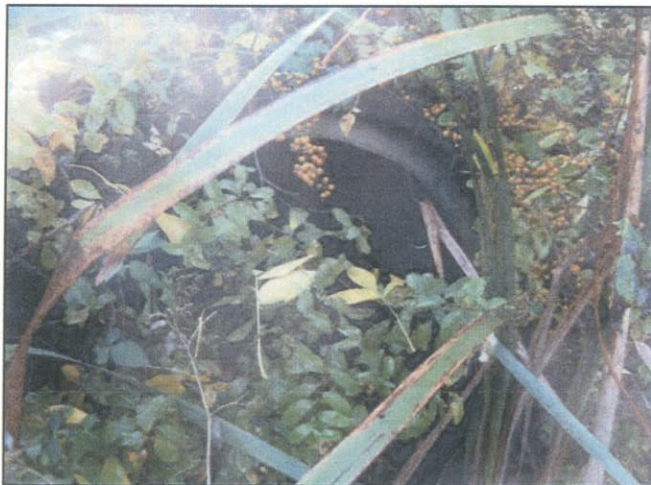
| INSPECTION #6 | Inlet | Outlet |
|---|---|--|
| <b>General Comments:</b> | - Dense vegetation<br>- Few small stones | - Dense vegetation<br>- Culvert partially buried |

Inlet looking southeast

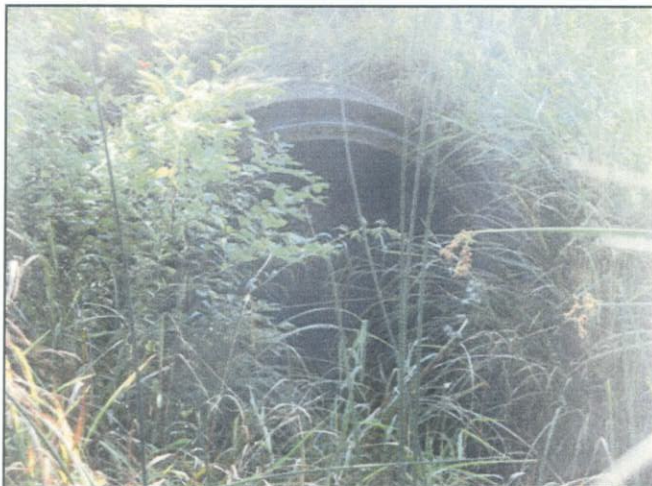
Outlet looking west

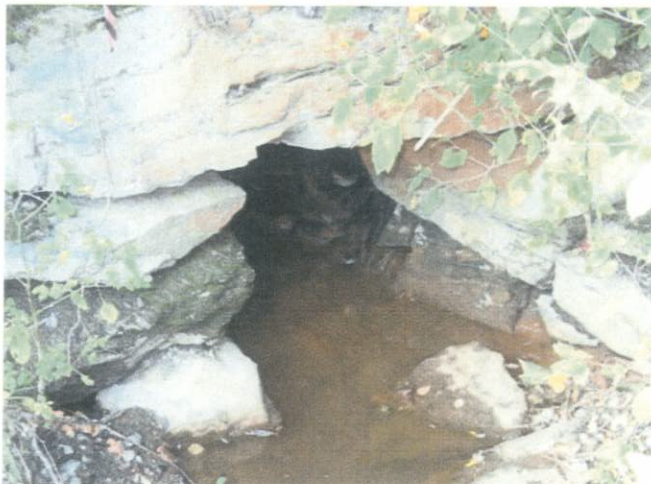
| INSPECTION #12 | Inlet | Outlet |
|---|--|---|
| <b>General Comments:</b> | <ul style="list-style-type: none"> <li>- Outfall from Seacoast RV appears to be corroded pipe (rust colored flow)</li> </ul> | <ul style="list-style-type: none"> <li>- Ditch slopes have been stabilized with fabric</li> <li>- Significant erosion has occurred at this location</li> <li>- Recommend additional stabilization of outfall ditch</li> </ul> |

Outlet looking north

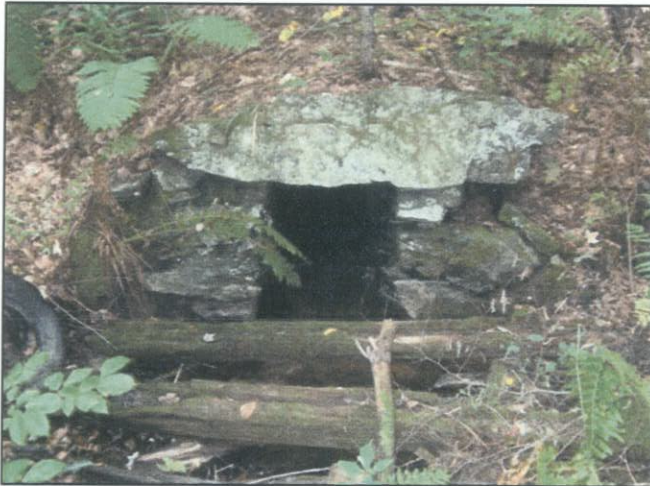
| INSPECTION #14 | Inlet | Outlet |
|---|--|---|
| <b>General Comments:</b> | - Tree debris/trash at inlet should be removed | - Erosion could be remedied with some stabilization such as riprap |

Inlet looking southeast

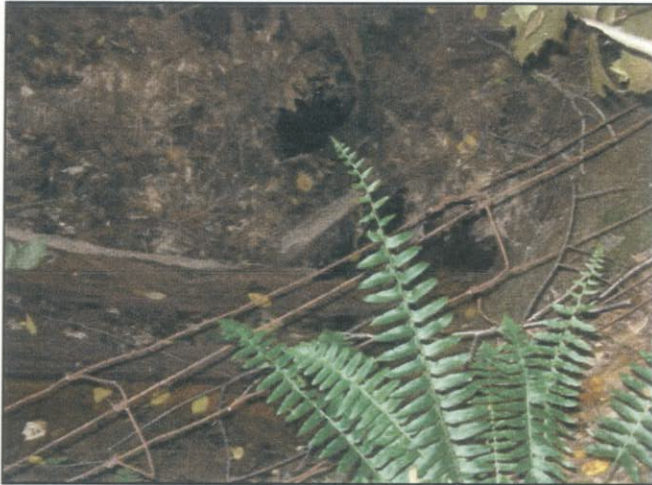
| INSPECTION #16 | Inlet | Outlet |
|---|--|--|
| <b>Condition of Culvert:</b> | Poor due to blocked inlet | Poor due to eroded slopes and debris |
| <b>General Comments:</b> | <ul style="list-style-type: none"> <li>- Inlet plugged with eroded soils, roots &amp; tree debris</li> <li>- Unable to locate pipe culvert</li> <li>- Appears to be remnants of 2' x 2' granite stone box culvert</li> </ul> | <ul style="list-style-type: none"> <li>- Outlet covered by large tree and root system</li> <li>- Unable to locate pipe/culvert</li> <li>- Erosion could be remedied with stabilization</li> <li>- Appears to be remnants of 2' x 2' granite stone box culvert</li> </ul> |

Potential inlet looking east

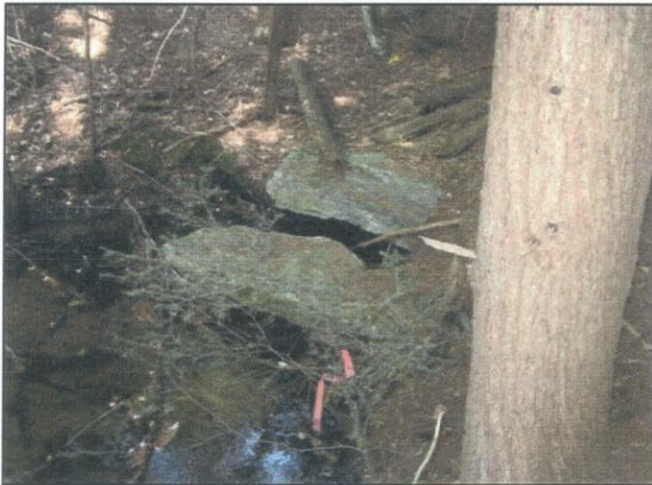
| INSPECTION #19 | Inlet | Outlet |
|---|--|---|
| <b>General Comments:</b> | <ul style="list-style-type: none"> <li>- Inlet has ponded water 4'-6' deep at granite box</li> <li>- Unknown structure size (approx. 6' wide x 4'-6' deep)</li> <li>- No signs of 60" CMP</li> <li>- Length to outlet is approximately 150 feet</li> </ul> | <ul style="list-style-type: none"> <li>- Culvert embedded into ground, thus flow potential has been reduced</li> <li>- Flowing with 14" water at time of visit</li> </ul> |

Inlet looking north

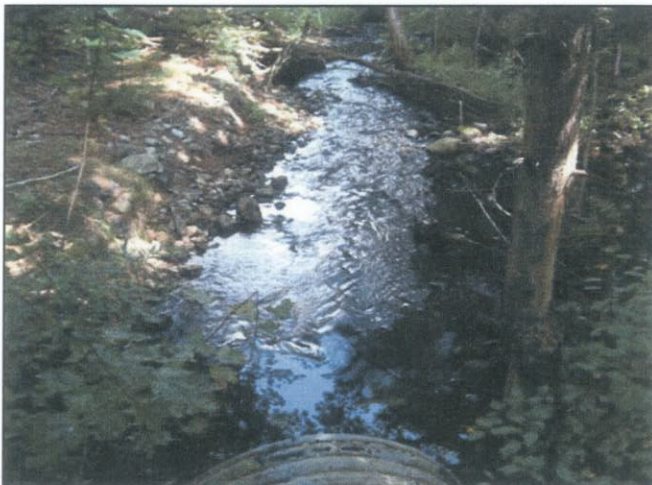
Outlet outfall looking north

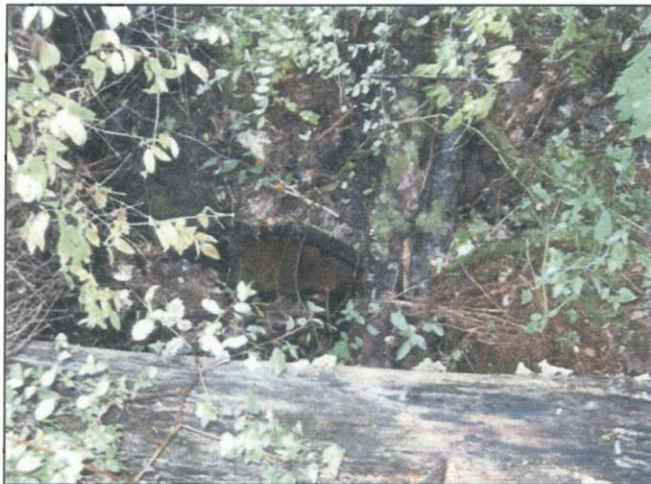
| INSPECTION #21 | Inlet | Outlet |
|---|--|--|
| <b>General Comments:</b> | <ul style="list-style-type: none"> <li>- Slight flow of water (less than 1")</li> <li>- Ditch has dense vegetation and tree debris that should be removed</li> </ul> | <ul style="list-style-type: none"> <li>- No flow exiting outlet</li> <li>- Build-up sediment restricting flow</li> <li>- No signs of steel pipe</li> </ul> |

Inlet looking east
